IMPROVING THE CANE KNIVES

By D. J. L. HULETT

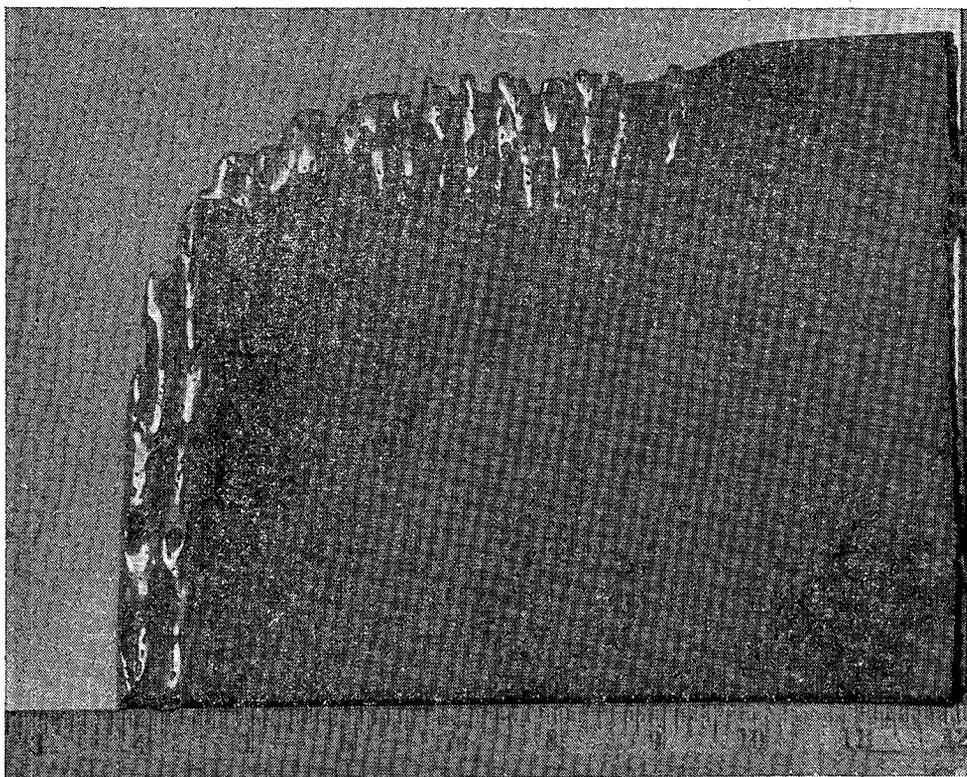
Photograph No. 1.

The knives were hard surfaced with Cobalarc I.A. on the flat or non-chamfered side of the knife. The hard surfacing beads were laid close together but not touching and the end of each bead looked directly into the cane as the knife rotated (see photograph No. 1). The idea behind this was that the softer metal of the knife itself would wear away and leave the ends of the tungsten carbide beads proud, as a number of sharp, pointed fingers. These points, at the cutting edge of the knife, tear into the cane and shred it (see photograph No. 2).
