### BOILER EQUIPMENT: TYPICAL ANOMALIES AND THEIR EFFICIENCY CONSEQUENCES

<sup>1</sup>John Thompson, a Division of ACTOM (Pty) Ltd, Cape Town, South Africa

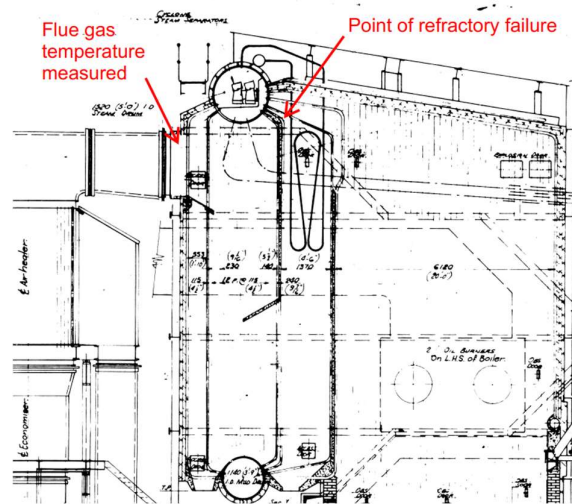
The original boiler flue gas outlet temperature is 385°C at the Maximum Continuous Rating (MCR), but due to a local mainbank castable refractory failure in the superheater cavity (refer to Figure 2), the flue gas temperature increased considerably across the boiler outlet duct.

Figure 2. Boiler arrangement showing the location of refractory failure

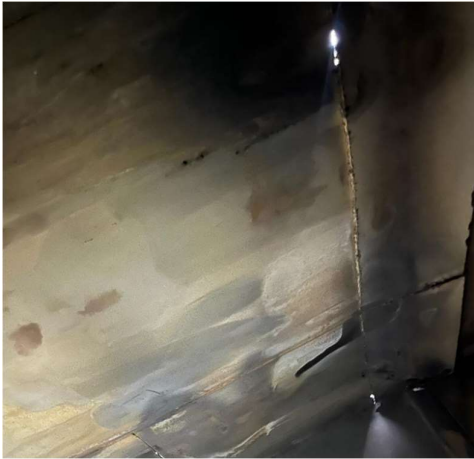
This case study focuses on tramp air ingress that occurs from the boiler back-end through to the economiser, based on the boiler described in the first case study. The tramp air ingress was deduced from visual inspection findings, which included failed expansion joints, worn rope seals, as well as other compromised sealing surfaces across the air heater, with a lesser extent noted across the economiser bank. Figures 3, 4 and 5 illustrate the failure of the air heater casing, the degraded rope seals and the corroded tubes at the bottom of the air heater, which all contribute to the ingress of tramp air.

Figure 3. Failed air heater casing

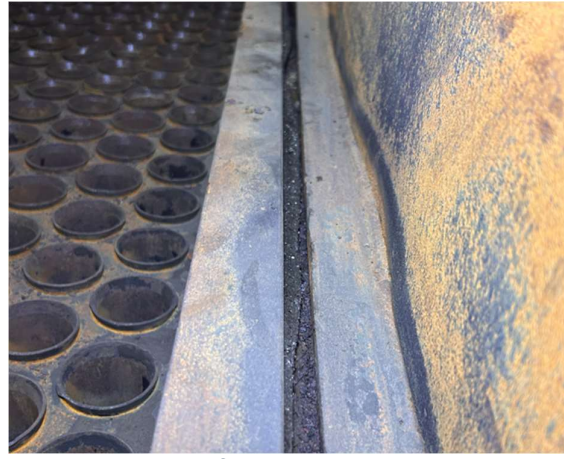
Figure 4. Defective air heater rope seal

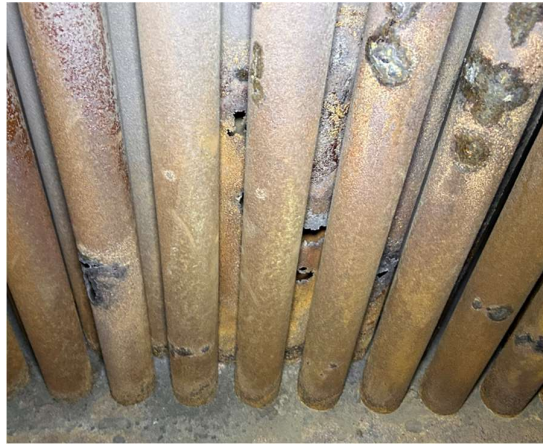
Tube corrosion in the air heater typically occurs during boiler start-up, due to dew point condensation at the coldest part of the air heater tubes, particularly when the air heater bypass is not engaged. The lowest metal temperatures are found at the cold air inlet side, near the bottom of the air heater, where the flue gas temperatures are also at their lowest. When the tube metal temperature falls below the flue gas dew point, condensation forms on the tubes, which leads to progressive corrosion.

In cases where coal is used as a supplementary fuel, the risk of corrosion increases. The tube metal temperatures at these cold spots can fall below the sulphuric acid dew point, which results in sulphuric corrosion over time. This degrades the tube integrity further and contributes to the reduced boiler efficiency and increased maintenance requirements.

Figure 5. Corroded air heater tubes

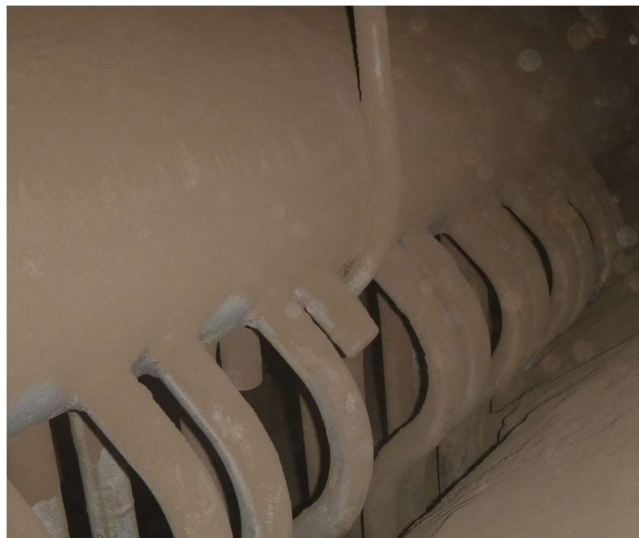
Upon the examination of the superheater outlet header during the annual boiler inspection, five missing superheater elements were identified (see Figure 6). These elements had been removed and blanked off, due to the previous tube failures that had occurred over several years. Such failures are common in pendant-type superheater tubes and are often attributed to rapid boiler start-ups.

Typically, superheater tube failures occur when steam condenses inside the tubes during start-up and shut-down, and it collects at the elbows near the bottom of the tubes, which is a common phenomenon in non-drainable superheaters. Under normal start-up conditions, this condensed water has sufficient time to evaporate, which allows steam to flow through and cool the tubes, as they are exposed to increasing radiative and convective heat flux from the flue gases. However, during a rapid boiler start-up, the water collected in the elbows may obstruct the steam flow, which prevents proper cooling. As a result, the tube metal is exposed to high flue gas heat flux without adequate internal cooling, which causes the metal temperature to rise above the tube's design limit.

This temperature elevation leads to metal creep - a permanent deformation of the metal under sustained high temperature and stress - which eventually results in tube failure. The repeated occurrence of this failure mechanism necessitates the removal and blanking off of the affected superheater elements.

Figure 6. Missing superheater elements visible at the steam outlet header

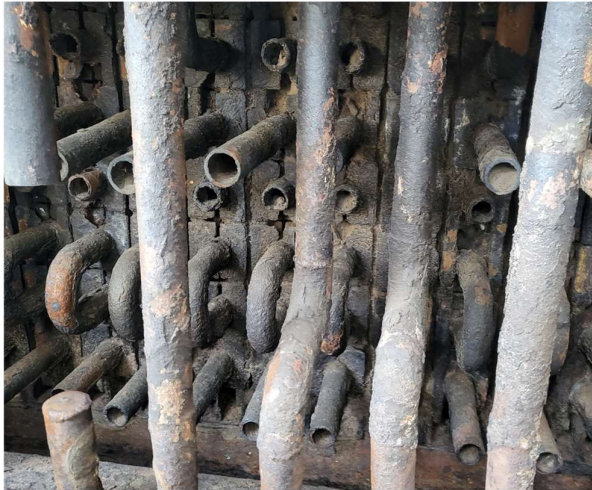
During an annual boiler inspection, it was observed that 6 of the 16 economiser elements were heavily corroded and subsequently blanked off by the mill, to prevent further leaks during operation. The corrosion of economiser elements typically occurs at the bottom economiser feedwater inlet (in this case, the economiser was of a counter-flow arrangement) during start-up, when the flue gas temperature is at its lowest. This results in lower tube metal temperatures and, subsequently, dewpoint corrosion on the external surface. Over time, the tube wall thickness fails to meet the minimum design criteria, which leads to premature tube failure. Refer to Figures 7 and 8 for illustrations of the condition of the economiser and tubes. With supplementary coal firing, sulphuric dewpoint corrosion can also result in tube failure, as well as erosion, due to high ash- and sand- loading in the flue gas.

Figure 7. Economiser with six elements blanked off

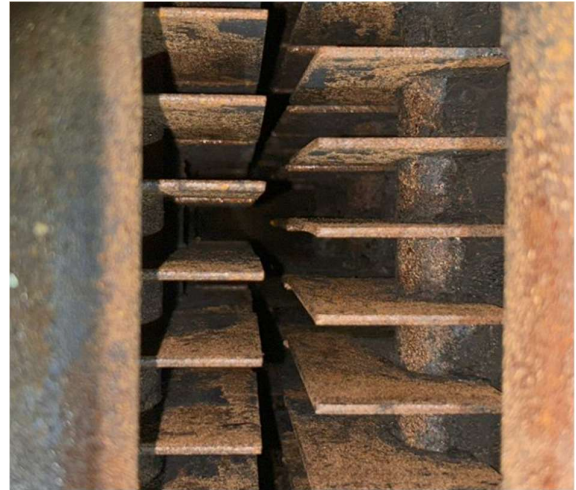
Figure 8. Corroded economiser elements
