BOILER FLYASH AND EFFLUENT DISPOSAL AT UMZIMKULU

SSGGOVENDER

Umzimkulu Mill, Port Shepstone, South Africa

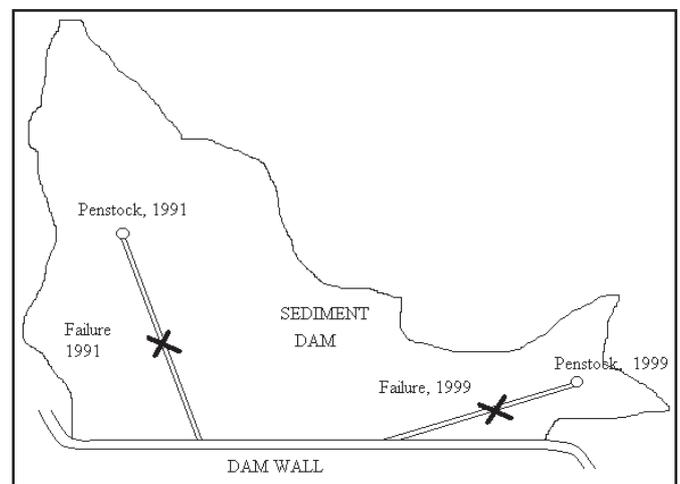
The concrete draw-off pipe from the penstock collapsed twice (1991 and 1999) resulting in uncontrolled release of sediment from the dam. Soon after the second failure an inspection of the draw-off pipe via a manhole revealed extreme corrosion of the concrete on the inner wall of the manhole. The corrosion was attributed to the presence of sulphuric acid found mainly in the sewage sludge but also to a limited extent in the coal ash. The Municipality sewage disposal into the dam was stopped immediately after the incident.

Another threat to the continued operation of the dam had to be contended with. In 1997 engineering geologists condemned further use of the dam. In their opinion it was not possible to evaluate the efficiency of the filter drainage system in the dam wall. They were concerned that the water table would rise within

FIGURE 1. Map of the sediment dam showing the locations of the spine drain failures.

the dam with further raisings of the dam wall and make the wall vulnerable.

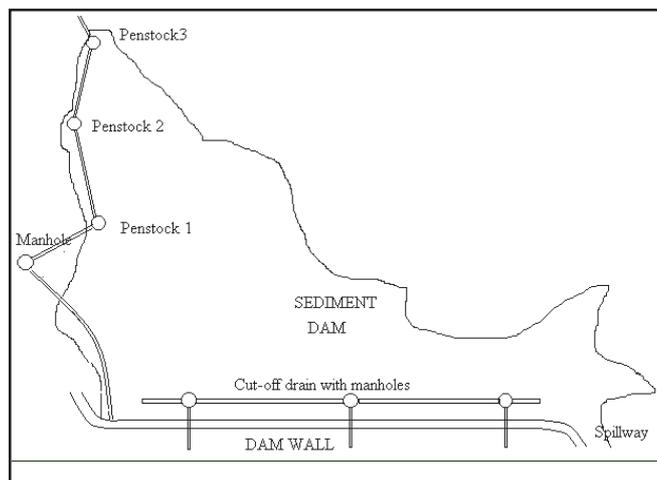
FIGURE 2. A schematic layout of the sediment dam upgrade during the 1999/2000 off-crop.

The dam wall was raised a further two metres. A new 450mm I.D. Weholite HDPE draw-off pipe was laid that spans the furthest reaches of the dam. Three new concrete penstocks feed the pipe. The penstocks have a 150mm thick inner lining constructed from concrete made using calcium aluminate cement. The HDPE pipe and the calcium aluminate cement were specified to resist the acid attack.

To counteract the effect of the rising water table on the dam wall a new elaborate cut-off drainage system was constructed upstream and parallel to the toe of the raised dam wall. The design of this system was based on experience with a similar one at the Sezela mill where piezometers, installed to measure
