# 3 CR 12 TUBE FAILURES IN KESTNERS – KOMATI MILL

DC OLWAGE

*Transvaal Sugar Limited, Komati Mill*

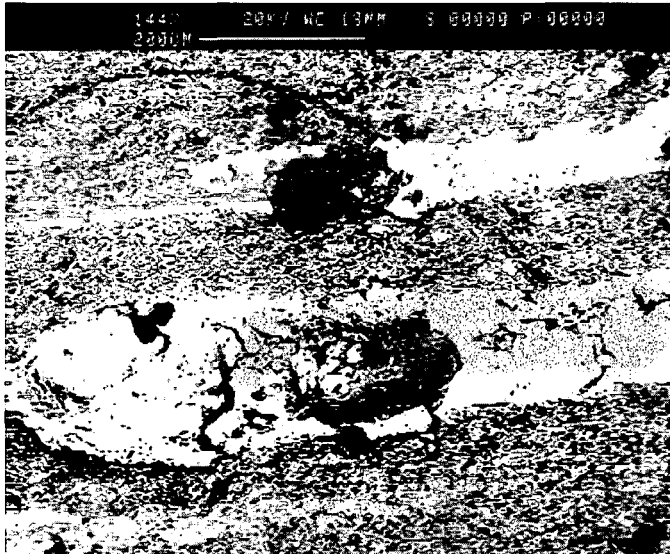
- The pitting corrosion was observed on both inside and outside the tube – randomly distributed and appeared to be more prominent on the inside of some of the tubes examined. Other samples showed severe pitting originating on the outside of the tube.
- The pitting corrosion observed could not be related to the weld metal or HAZ but occurred randomly with the worst pitting corrosion occurring in the parent metal adjacent to the weld (in the approximate vicinity of a scratch). Figure 2 shows that the pitting corrosion occurred in the mechanically damaged (scratched) areas.

FIGURE 2: Mechanical damage (scratch) with pitting corrosion products visible (114 X).

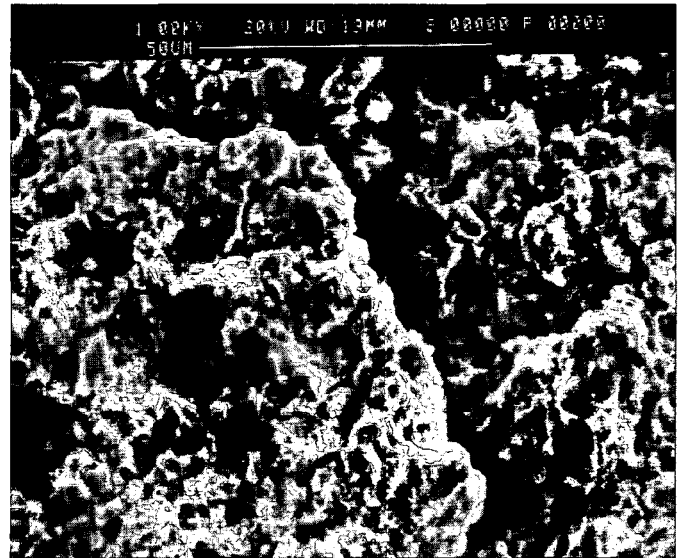
- SEM analysis indicated that the mode of failure changed from intergranular to transgranular as the stresses per cross sectional area leading up to failure increased. The failure of the tubes could therefore be attributed to intergranular corrosion (see Figure 3).

FIGURE 3: SEM photomicrograph showing cracking (1000 X)
