# FIRST IMPRESSIONS OF ADI CHAIN INSTALLED IN THE AMATIKULU DIFFUSER

Amatikulu Sugar Mill has installed Austempered Ductile Iron (ADI) block links and side plates on two diffuser chain strands. These links were cast in South Africa at a substantially lower cost than forged chain links. Some development emerged concerning the pattern, casting procedures and quality assurance required to ensure that high quality links were produced. Extensive tests were performed on the new links, including tensile and ultrasonic tests, and the cutting of cast links to inspect casting quality and procedure. Old links were also tensile-tested for comparisons.

The two chain strands have been in use for one season and have proven successful. Some links were disassembled for inspection after one season and the inspection results of these links and the rest of the chain are discussed.

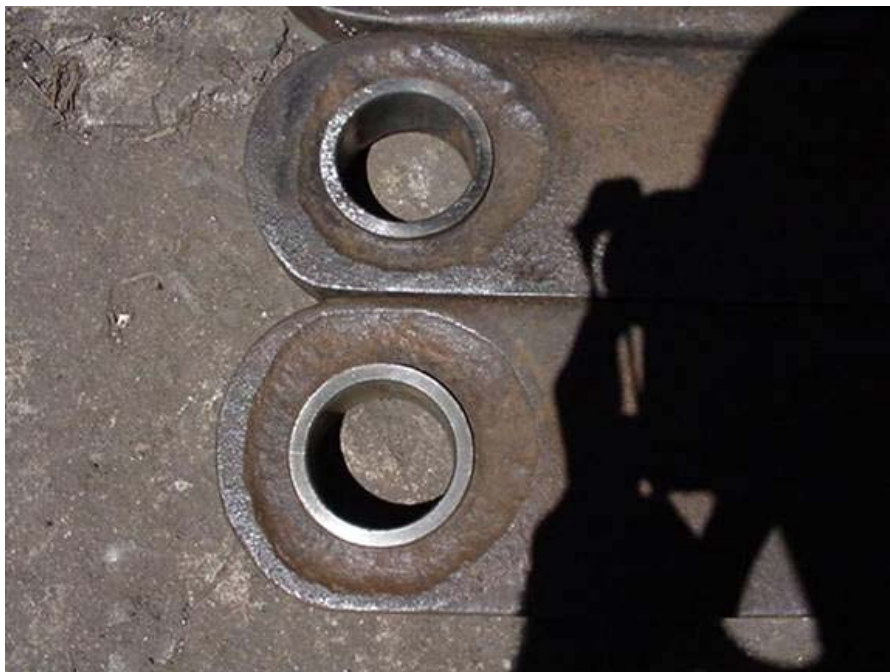
The links have also suffered corrosion-erosion around the bush journals (see Figures 1 and 2). Shown in Figure 1 are typical examples of the corrosion-erosion that is present on most of the old Ausrex links. The corrosion is deepest close to the bush, and varies from 3-6 mm depth. The corrosion weakens the link by reducing the cross-sectional area, it also causes the bush-ends to crack (Figure 2). The inner link in Figure 2 shows initial stages of corrosion around the bush. Note that the bush is cracked on both ends; this introduces bending stress in the pins and the links.

**Figure 1. Worn Ausrex chain outer links.**

The corrosion always occurs between mating faces of the inner and outer links, concentric around the bush. Galvanic corrosion is expected around the stainless steel bush caused by the galvanic cell formed by the stainless steel bush and the manganese steel links. Cane fibre also enters the gaps between the inner and outer links; this will wear the corrosion layer away. These two processes contribute to the corrosion-erosion seen between the mating surfaces on the links.

This corrosion highlights the need for diffuser liming or some other means of pH control. The juice pH in the diffuser should ideally be maintained at no lower than 6 and no higher than 7 for overall optimisation of the diffuser. The pH in the diffuser should be closer to 12 to prevent corrosion, which will be unacceptable for the extraction process. Therefore some corrosion will always be expected. As yet, no corrosion is evident on the new chain.

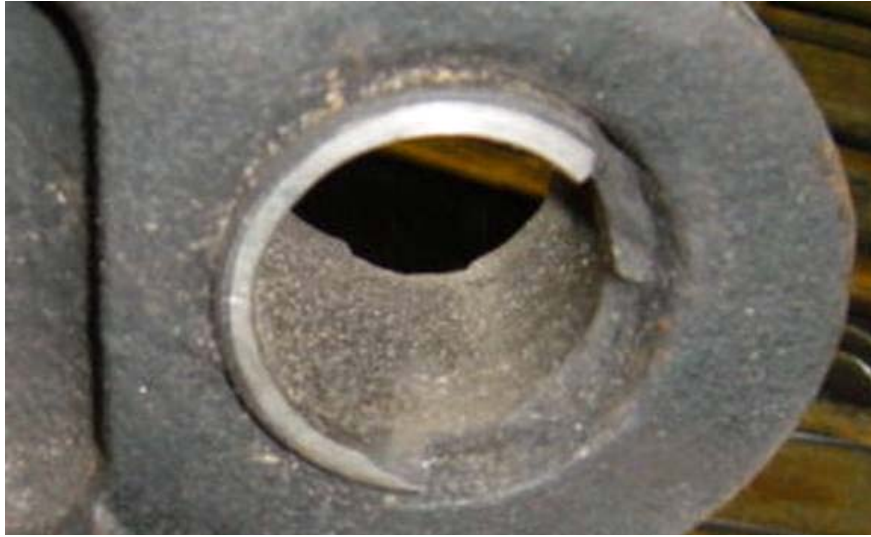
**Figure 2. Worn Ausrex inner link.**

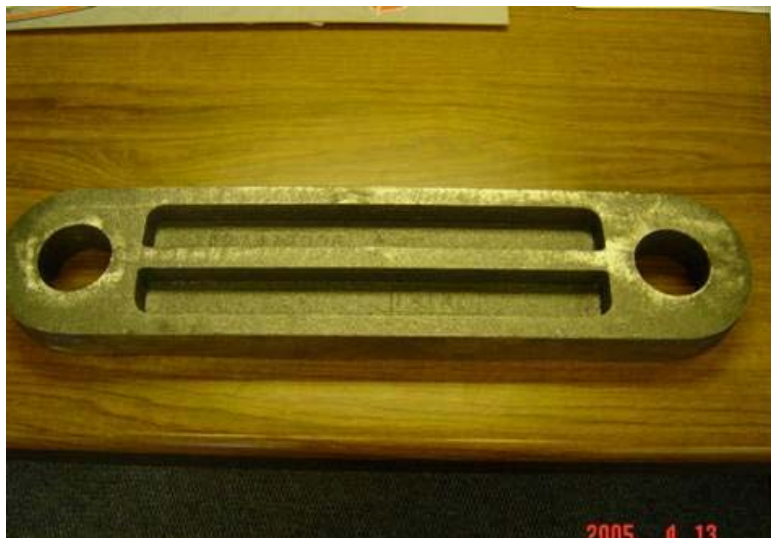
**Figure 3. Experimental side link with added centre stiffener.**

The slight warping of the outer links was corrected by simply machining the links to size after allowing a substantial casting allowance. The pattern of the side-link has now been altered to introduce a rib parallel to the link flanges, which has eliminated the warp without adding excessive weight to the chain (see Figure 3).

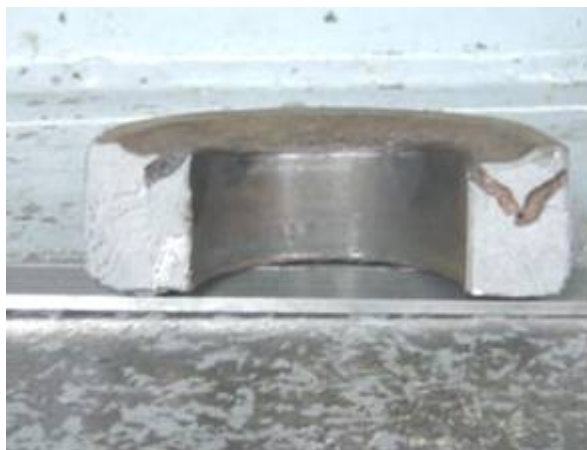
Figure 4 shows the first sample, failed at the bore of one of the outer links. Figures 5 and 6 show the mating fractured planes of the old links. Figure 5 is most interesting as it clearly shows inherent defects in the cast, which were not apparent on visual inspection before testing. The defects have possibly been developed further by corrosion. Note the pattern of the hollows running at 45° from the bottom of the corrosion crater close to the bush. The new cast links initially slipped in the machine jaws under tension, and were then rotated 90° so that the jaws could grip the flanks of the flanges, which had been machined to size. The new chain broke at a safety factor of 7.5, failing on an inner block link, revealing a shrinkage defect at an ingate point (Figures 7 and 8).

**Figure 5. Failed section B1-B2-L1-L2.**

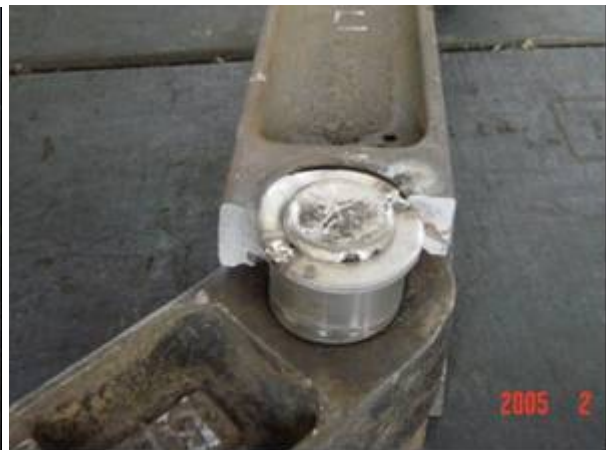
**Figure 6. Mating failed section to Figure 5.**

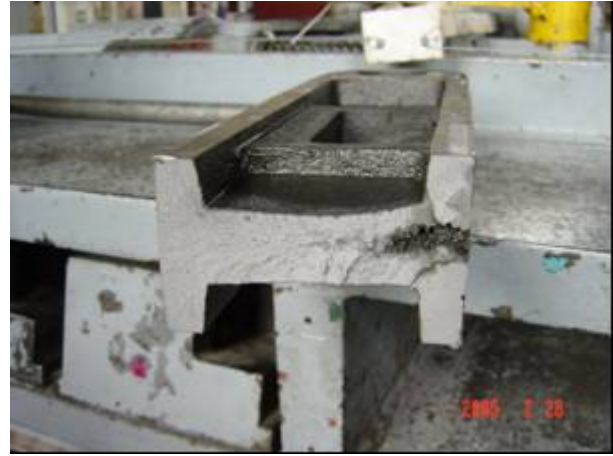
Figures 7 and 8 show the new link sample, failed at a short distance away from the bores with an obvious shrinkage defect, about 30 mm long. The strength was commendable even with the casting defect. No defect had been apparent before the test. Another tensile test was conducted on March 9 2005, where the old links which had failed to grip were re-tested, along with three new ADI links. The results of all the tensile tests can be seen in Table 1, and Figures 10 to 20 in Appendix III.

Figure 8. Mating section to Figure 7.

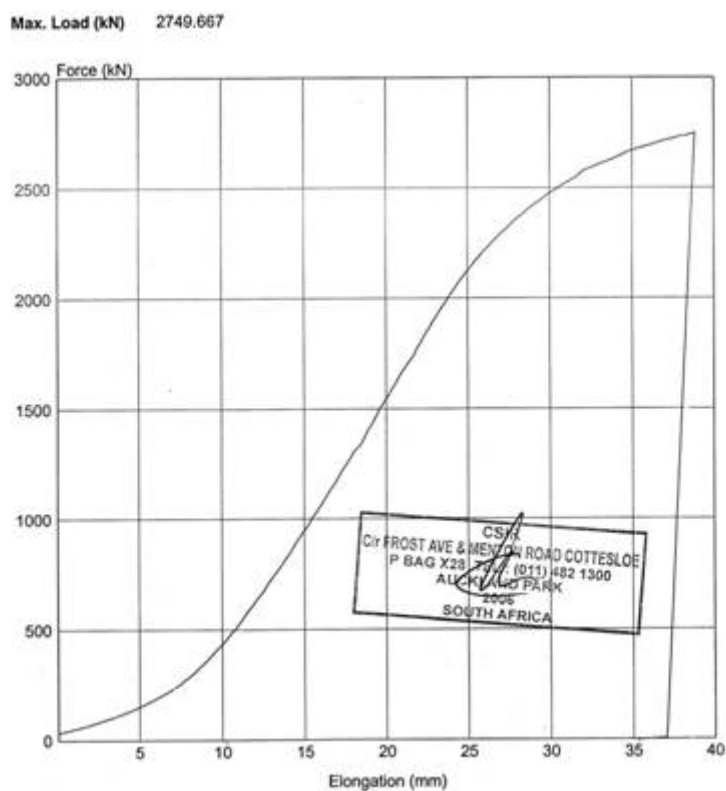
Figure 9 is a typical stress-strain graph of the tested links. There is an initial elongation at low load which gives way to a linear stress-strain relationship, until the link assembly starts to yield plastically. The 'reduction' in strain after the breaking point is due to the 'spring' in the machine itself<sup>2</sup>.

**Figure 9. Typical stress-strain graph of the ‘new link 1’ sample shown in Figures 7 and 8.**

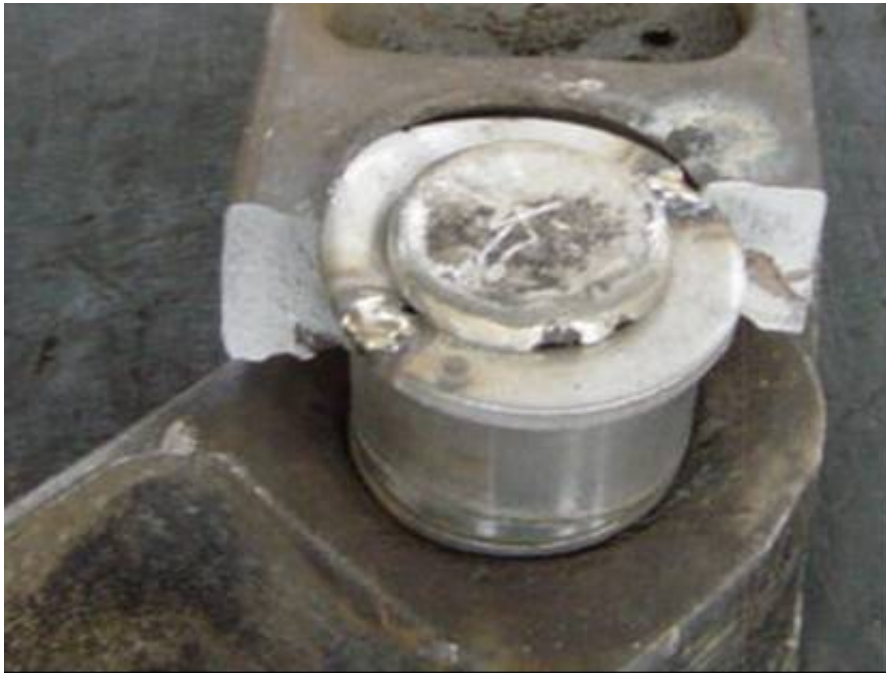
**Figure 10. Failed test sample B1-B2-L1-L2.**

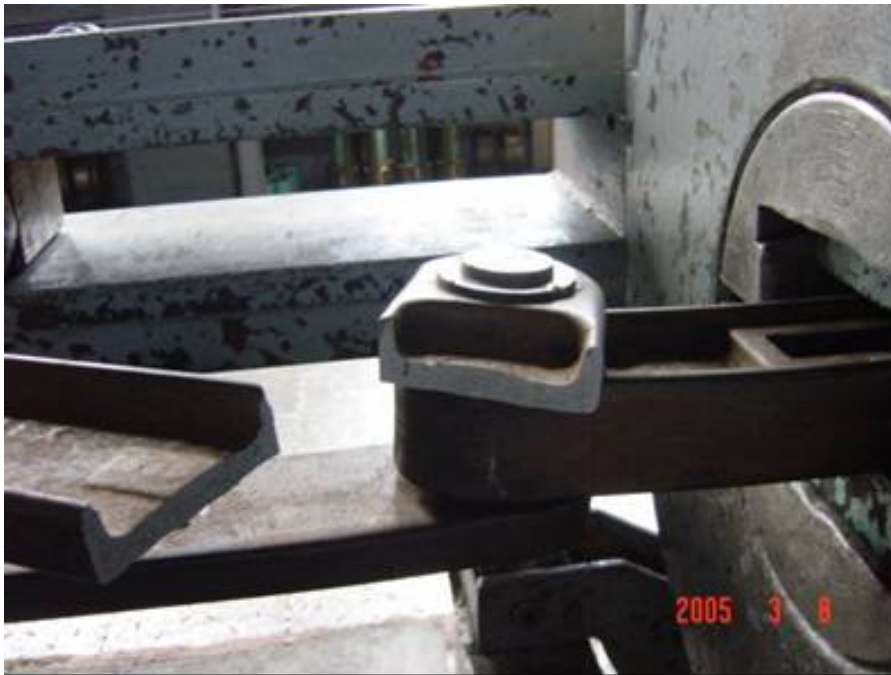
**Figure 14. Failed test sample B3-B4-L3-L4.**

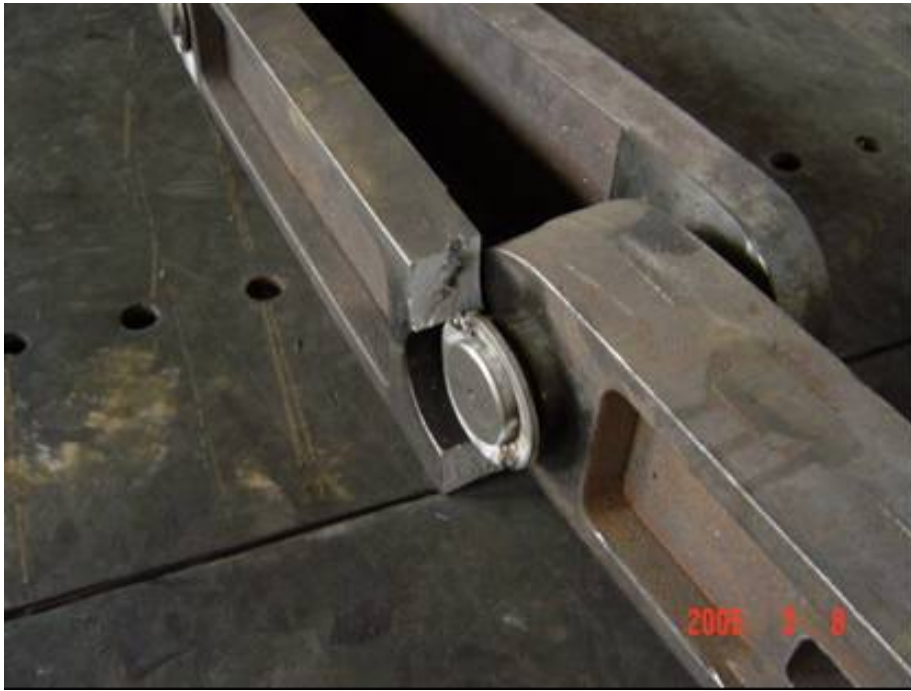
Figure 16. Failed defective new link 2 sample.

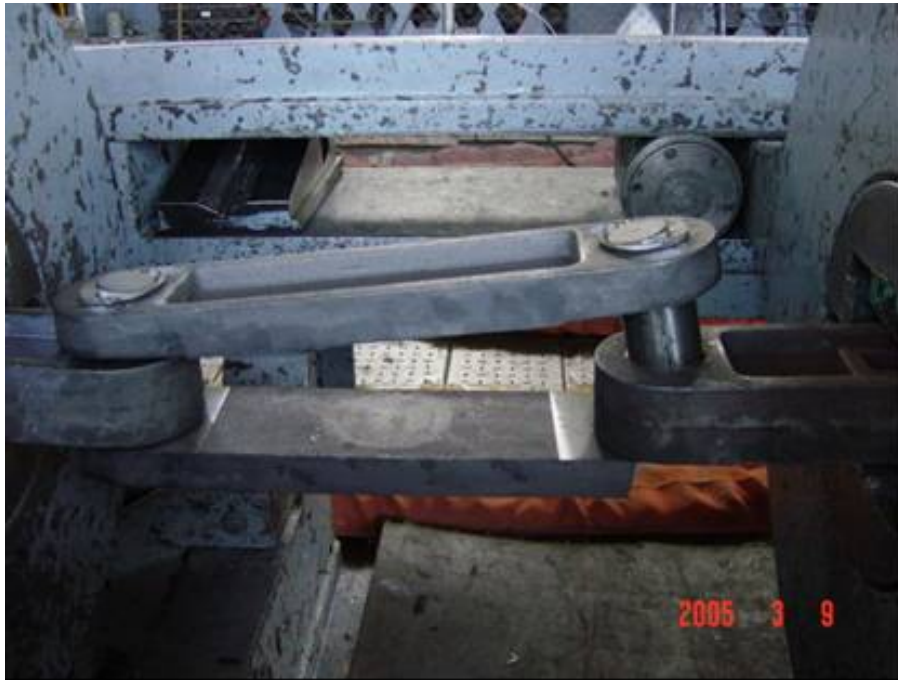
**Figure 18. Failed new link 3 sample.**

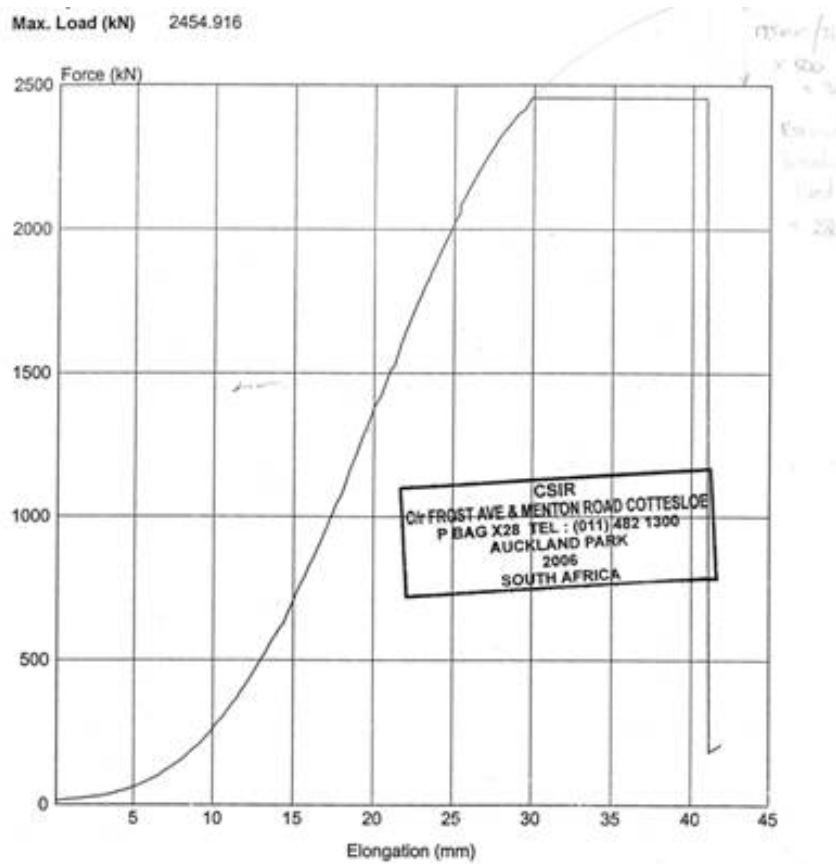
\*The 2800 kN figure was extrapolated from the graph. The machine operator had incorrectly set the graph scale at 2500 kN instead of 3000 kN.

The breaking load in figure 19 was estimated from the graph as 2800 kN.

**Figure 19. The stress-strain graph of the new link 3 sample, with the incorrectly scaled graph.**

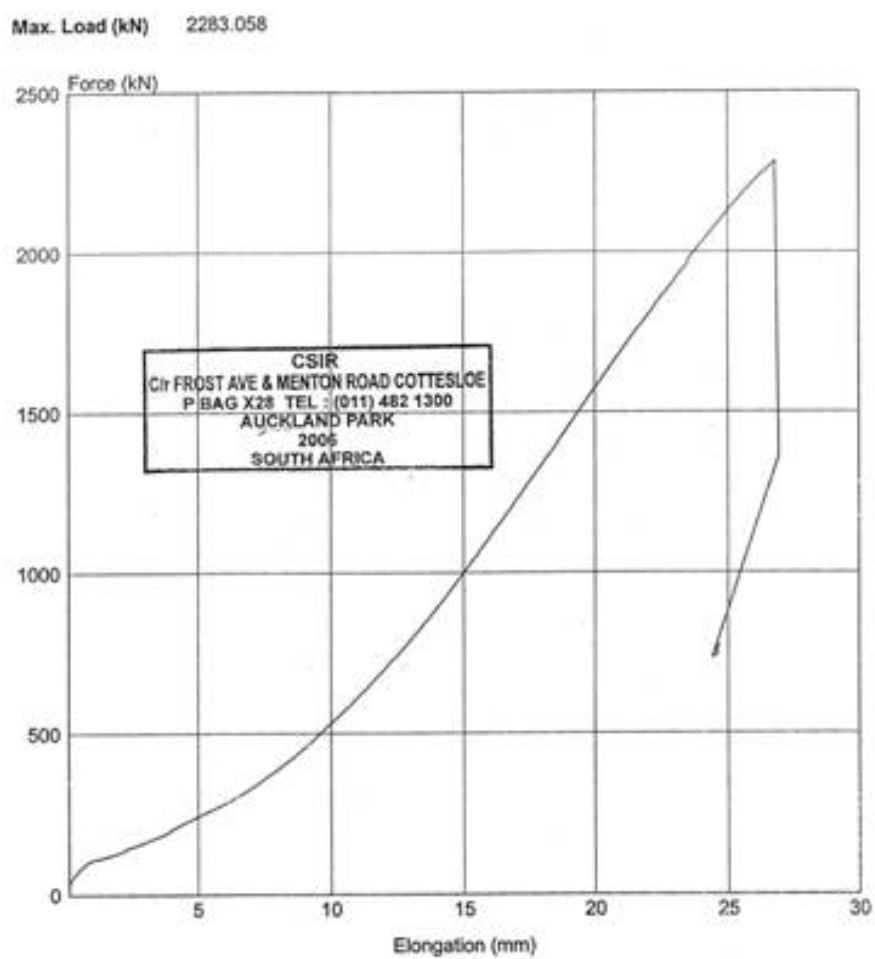
The pins in the links tested as shown in figure 20 pulled out of the links before fracture could occur.

**Figure 20. The stress-strain graph of the new link 4 sample.**
