# MECHANICAL REDESIGN OF ION EXCHANGE RESIN VESSEL BOTTOMS AT HULETT REFINERY

L SMITH

*Tongaat-Hulett Sugar Ltd*  
E-mail: [leon.smith@hulett.co.za](mailto:leon.smith@hulett.co.za)

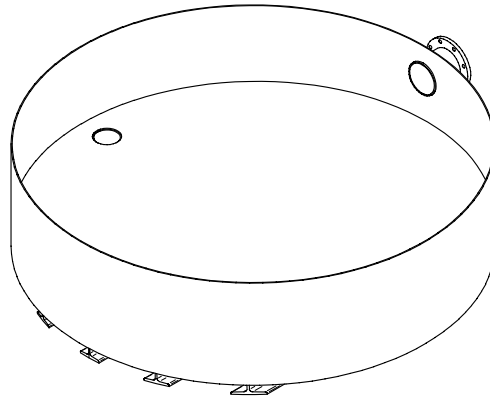
Later, one of the vessels with an Original Fabricated Flat Bottom (OFFB) (Figure 3) failed a statutory third party inspection by an approved inspection authority. A design check was done using Finite Element Analysis (FEA) and this indicated that excessive stresses existed in the shell above and below the bottom plate and support steel work of the flat plate. (See Appendix A for comments on the FEA and the third party inspection.)

**Figure 3. Typical layout of the original fabricated flat bottom.**

Comparing Tables 1 and 2, the question arises why the increase in failure rates of the LDSs on both the CDEs and the OFFBs occurs. It was found, during a statutory third party inspection when one of the OFFBs failed this inspection that the OFFB weakens due to metal fatigue and then starts to deflect more than the calculated values. It was also found when converting one of the CDEs to a torispherical Dished End (DE) with “Top Hat” and Stone Bed (THSB) system that the top 150 mm of the concrete was severely corroded and that it would be flexible under the operating pressure of 450 kPag. The increase of failures of the LDSs when the bottoms weaken and flexing increases, confirms this theory.

The failed OFFB was replaced by a RFFB. Appendix B provides comments on the FEA of the RFFB and reasons for its selection. Deflection indicators were installed below all the other OFFB vessels to enable a continuous monitoring of the integrity of all the remaining original bottoms. Fatigue failures of the remaining OFFBs are expected at random.

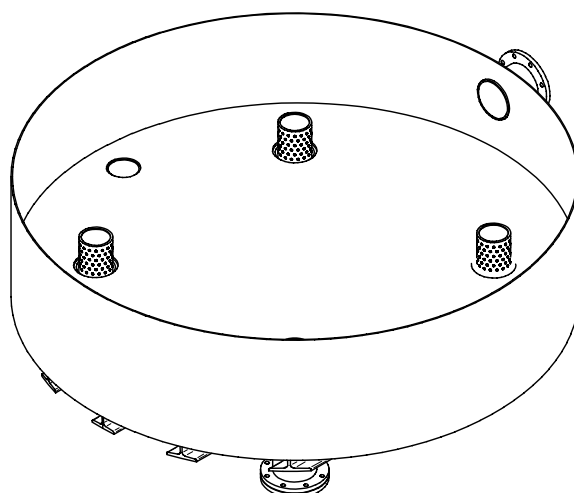
**Figure 5. Redesigned fabricated flat Bottom with four top hats installed (stones omitted for clarity).**

Redesigning started on the distribution system after it failed in the vessel with the RFFB. It was decided to use a system similar to the one in operation at Afprod Glucose plant in Germiston, which had given no problems since installation. This system, THSB, consists of a “top hat”, layers of graded stone above the “top hat” to form a stone bed and then the resin above the stone bed. The “top hat” installation forms the new collection point of the bottom distribution system. The stones form a filter that prevents the resin beads from escaping through the “top hats”. An additional strake was added to the bottom of the resin vessel to increase the height and volume, to compensate for the loss of resin volume created by the stone fill. A “top hat” installation with four “top hats” (Figure 5), was done on a spare RFFB before it was installed on one of the secondary vessels.

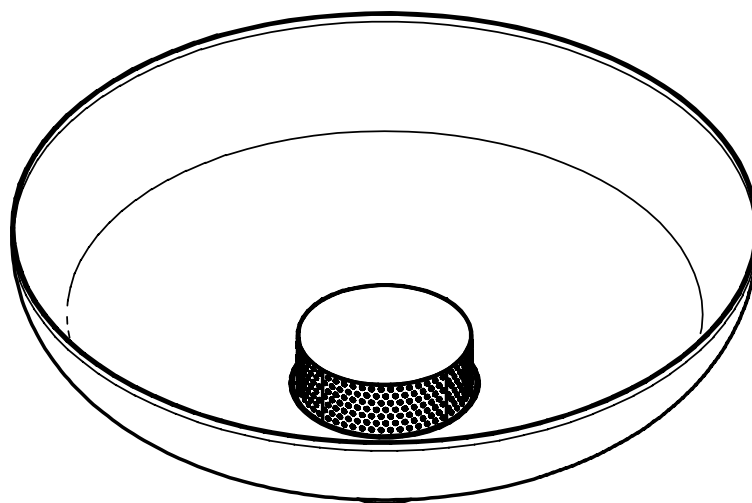
**Figure 6. Torispherical dished end with a single top hat installed (stones omitted for clarity).**

An increase of the failure rate of the distribution system in the primary vessels with the CDEs prompted a redesign of the distribution system in the vessels with these bottoms. A single large “top hat” was installed at the bottom of the dished end (Figure 6). The height of the vessel was also increased to allow for the loss of resin volume created by the stone bed that was loaded above the top hat.

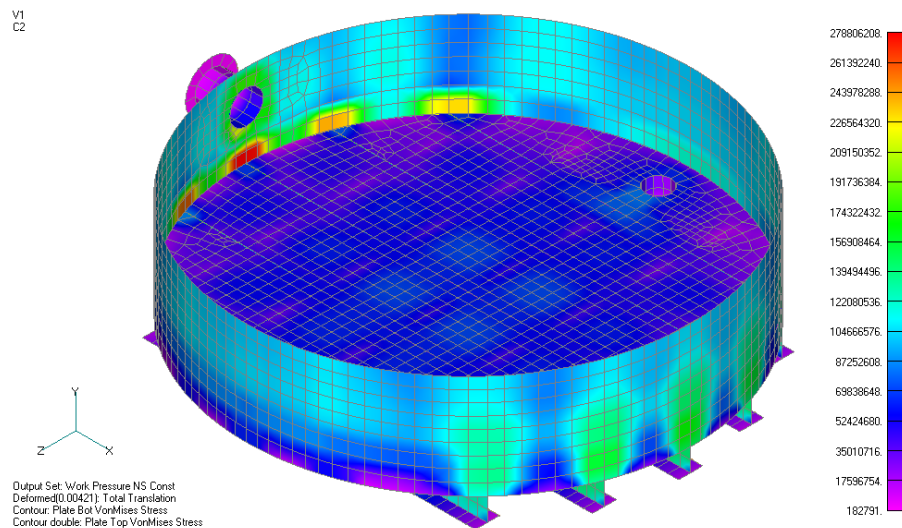
A FEA was done on the original fabricated flat bottoms to determine the expected deflections under normal operating pressure and test pressure. This FEA indicated very high stresses in the shell and support beams, as high as 280 MPa, which exceed the allowable stress of 150 MPa for “boiler plate” (BS1501-151-430A) up to a thickness of 40 mm and below a temperature of 100°C as specified in (BS5500: 1999 Specification for fusion welded pressure vessels). These high stresses indicated that a redesign of the bottom would be required.

A numerical model was generated using MSC visual Nastran. This model was meshed, loaded with operating and test pressures, constrained and analysed. Figure A1 shows the calculated Von Mises stresses on the bottom when the operating pressure is applied, which is typical of all the plots obtained, during the analysis of the various options. The calculated deflections and maximum Von Mises stresses are shown in Table A1.

**Figure A1: Von Mises stresses in original fabricated flat bottom (operating pressure applied).**
