EXPERIENCES OF MASSECUITE PIPELINE EXPLOSIONS CAUSED BY THE HIGH TEMPERATURE DECOMPOSITION OF MOLASSES

Abstract

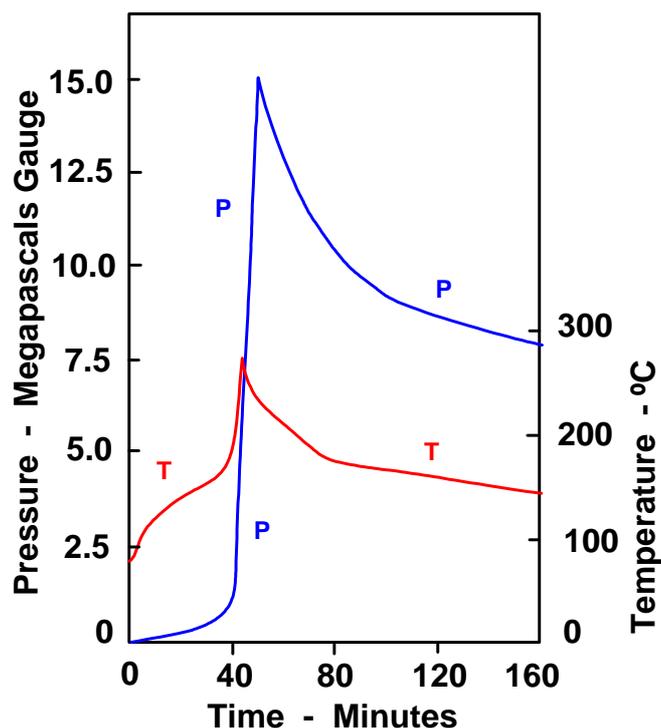
Experiments by Foster (1974) have, however, shown that the explosive decomposition of sugar can occur even when there is no amino acid present (i.e. it will occur with pure sucrose) showing that this cannot be the Maillard reaction. Foster's experiments were conducted by placing a product sample into a tightly sealed container (a 600 ml steel 'bomb') and then monitoring the rise in temperature and pressure within the container when the whole container was placed in an oven at a constant temperature. The products tested were pure sugar massecuite, A and C massecuites and final molasses. The oven temperatures tested were 122, 148 and 170°C. Most of the tests showed that there was an 'incubation time', after which there was a rapid rise in pressure, accompanied by a rise in temperature which indicated an exothermic reaction. An example of a test result is shown in Figure 1.

**Figure 1. Pressure development in C-masseccuite (Foster, 1974).
Oven temperature = 148°C; Normal steam pressure = 349 kPa gauge**

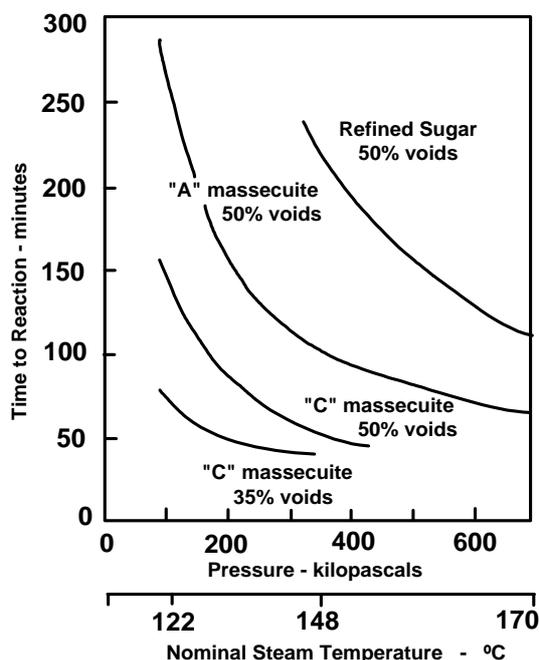
The results of the range of conditions tested by Foster are summarised in Figure 2, which plots the time taken for the reaction to develop (the 'incubation time') as a function of the temperature (and thus the pressure of saturated steam to which it corresponds). The curves show that the time to reaction is shorter for impure products and, in all instances, decreases as the temperature (and thus corresponding steam pressure) increases. The term '% voids' refers

to the proportion of the sample container not occupied by the massecuite sample. The results for 'C'-massecuite thus indicate that, with a larger sample mass, the time to reaction is shorter.

Figure 2. Summary of results in terms of time taken for the reaction to develop (Foster, 1974).

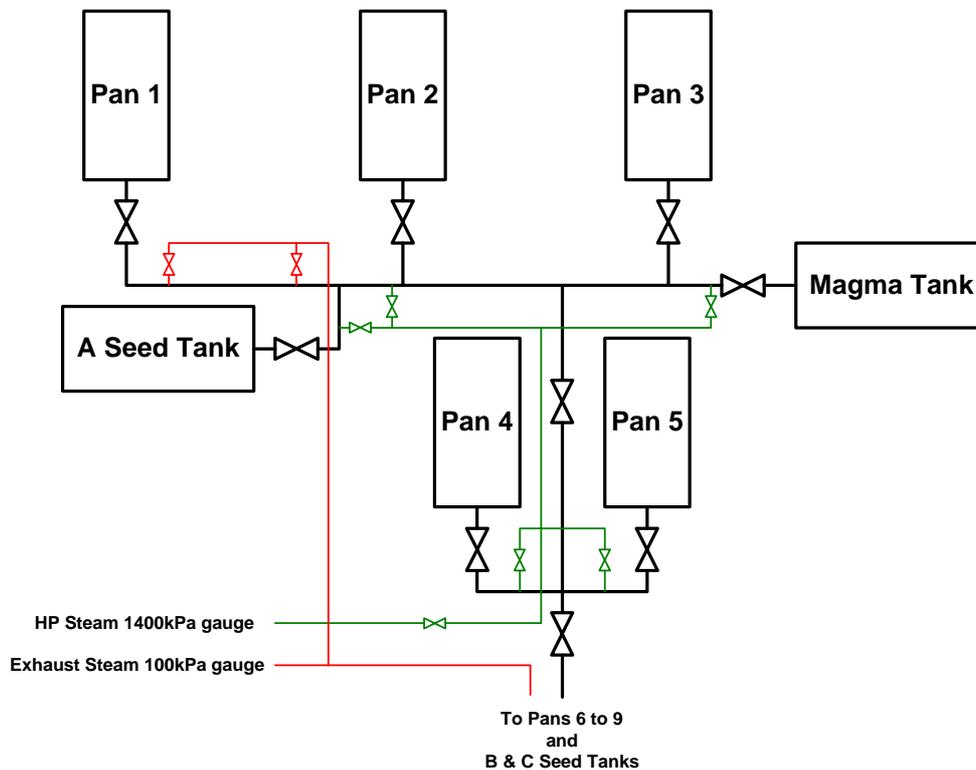
An explosion in a cut-over line at Darnall took place at 09h45am on 16 June 1978. An investigation at that time was able to track the sequence of events just prior to the explosion. These events need to be understood in the context of the cut-over piping arrangement shown in Figure 3. The relevant section of the cut-over system is the line interconnecting Pans 1, 2 and 3 with the A-seed tank and the magma tank. This section could be (and was at the time) isolated from the rest of the cut-over piping, by closing the relevant valve.

Figure 3. Darnall pan floor cut-over and steaming out system at the time of the explosion.

At the time it was thought that all the steaming out points on the cut-over system were supplied with exhaust steam. Although high pressure steam (1400 kPa – 200 psig) had been used previously for steaming-out, a ‘slight’ explosion in 1974, which blew the top off a cut-over valve, resulted in the decision to change all the steaming-out points to use exhaust steam (100 kPa gauge). Examination of the damaged piping after the explosion showed that a number of the steaming-out points had inadvertently been left connected to high pressure steam, as shown in Figure 3. Almost certainly, one of these high pressure steam valves was left open after the initial cut of the contents of Pan 2 into Pan 1. This then, could have caused the explosive decomposition of massecuite which had been left in the cut-over line after cutting the contents of the seed tank into Pan 2. It was not possible to prove conclusively that a valve had been left open, as two 20 mm valves on the high pressure steam lines were never found. Fortunately no one was injured in the explosion, but to understand the force of the explosion and the dangers it posed, it is necessary to describe some of the details.

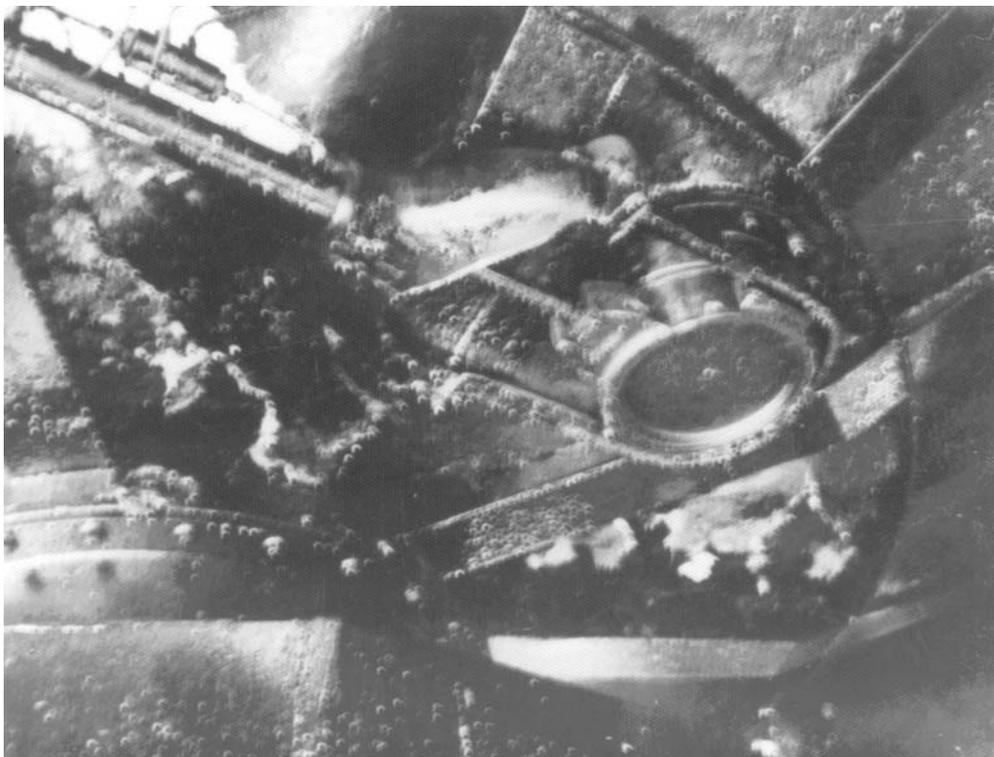
The explosion tore away a large section of the cut-over line below Pans 1 and 2. The pipe ripped off most of the body of the cut-over valve on Pan 1, leaving the valve tongue held on by vacuum, as shown in Figure 4.

Figure 4. Tongue of valve held onto base of Pan 1 by vacuum.

The most important recommendation is never to use high pressure steam for steaming-out massecuite lines. The maximum pressure steam which should be used is exhaust steam (approximately 100 kPa gauge), although it is clearly safer to use Vapour one (approximately 60 kPa gauge).

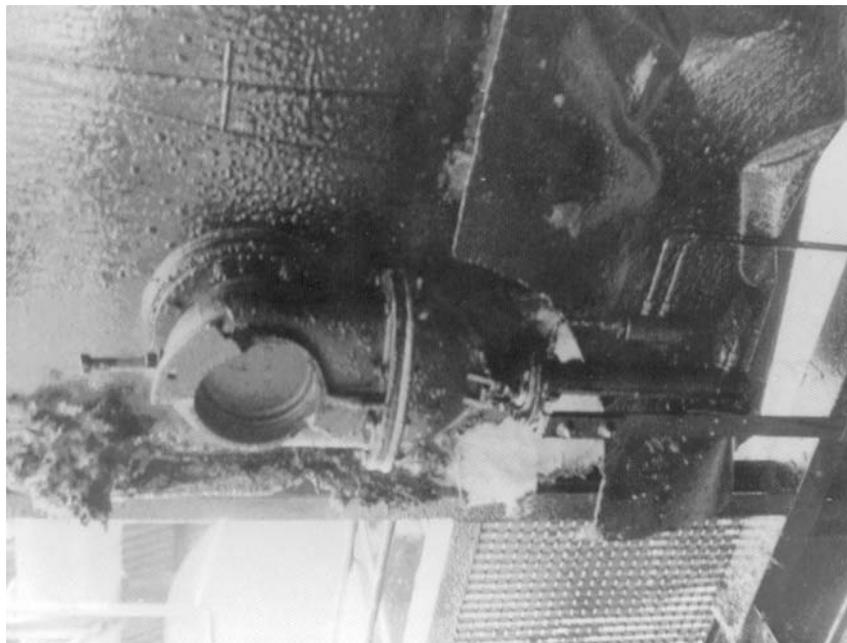
The cut-over valve on Pan 2 was ripped off completely and the full contents emptied into a crystalliser below, which fortunately had sufficient space to accommodate the massecuite. The valve on the seed tank was badly damaged (see Figure 5), and it was fortunate that the tank was empty at the time.

Figure 5. Damaged valve on seed tank.

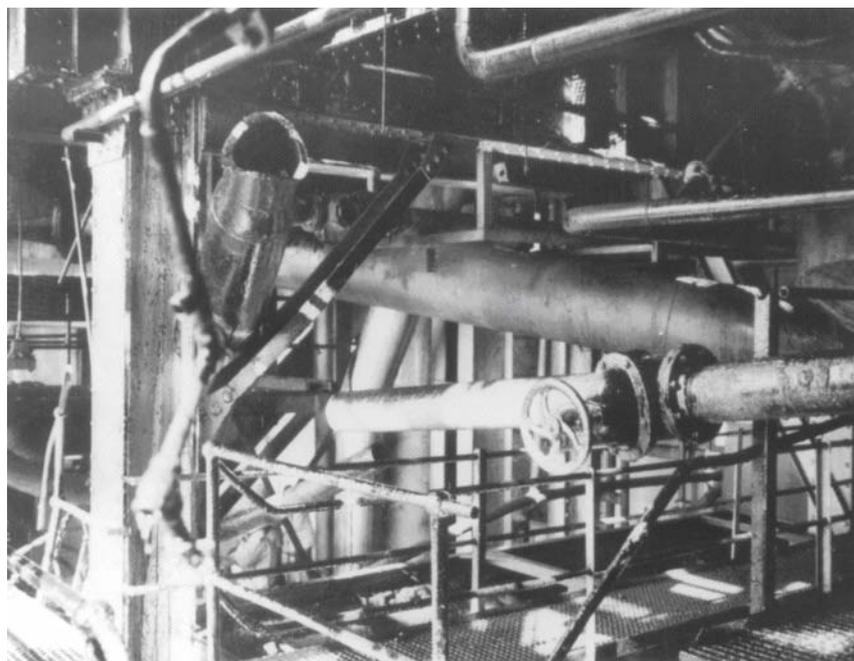
The section of cut-over pipe ripped away from the rest of the cut-over system, tearing away the saddle of a Tee-joint, as shown in Figure 6. As the 250 mm cut-over pipe tore away, it caused extensive damage to other piping (a 200 mm V1 line, a 150 mm water line) and to walkways.

Figure 6. Cut-over pipe torn away at saddle.

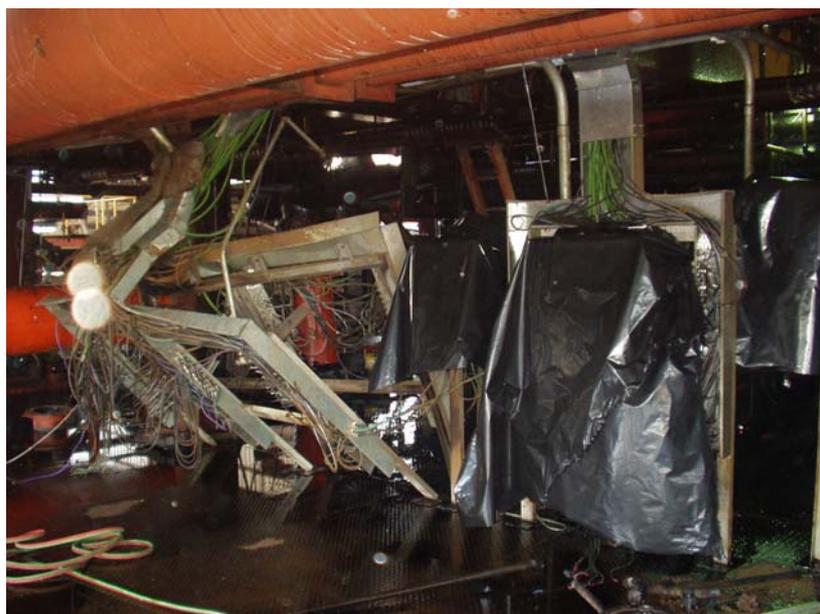
The explosion also flung metal onto a set of control panels and caused severe damage, virtually destroying three panels completely (see Figure 7). This affected the entire factory control system and meant a complete factory stop.

Figure 7. Damage to control panels.

Steaming out should be restricted to situations where the system is open to atmosphere. This can be achieved by providing a low level steamings tank (open to the atmosphere) where the dissolved products can gravitate and be collected before being pumped back into process.

As a further safety measure, bursting discs can be installed to provide the safe release of pressure in the event of an explosive decomposition reaction.
