# INTERMEDIATE CARRIERS

By C. E. DENT

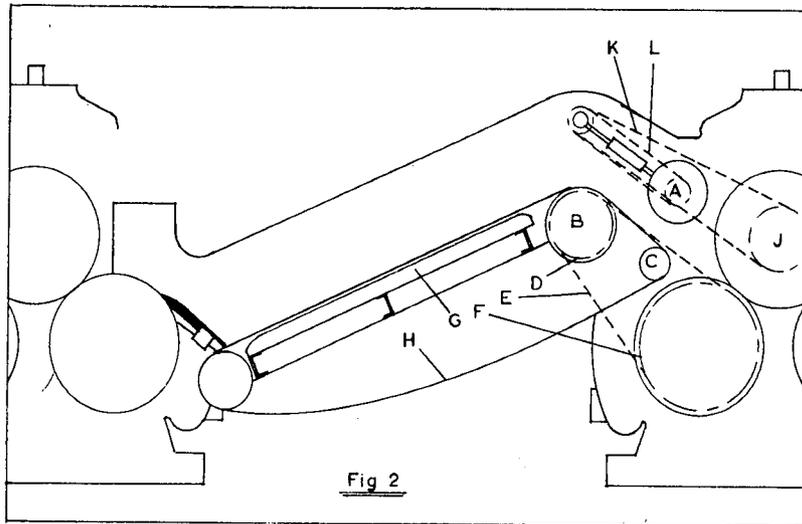
Fig 2

KEY TO FIGURE 2:

- |   |                            |        |                            |

| A | Overslung feeder drum. | D.E.F. | Drive sprockets and chain. |
| B | Drive shaft and sprockets. | G | Chain runners. |
| C | Nose shaft and idlers. | H | Chain Slat assembly. |

In 1950 the type of intermediate carrier most commonly used was the apron type of intermediate carrier as shown in figure 2. This type of intercarrier of which there are still a few in operation at the present time, uses overlapping steel slats riveted to three or four

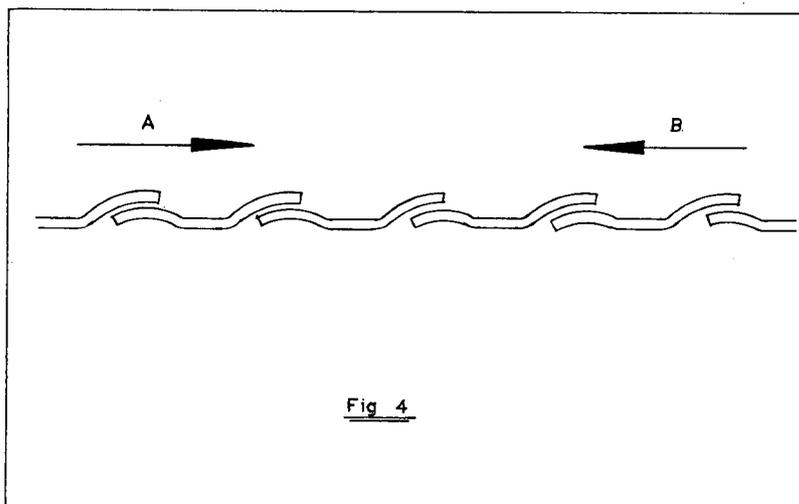
Fig 4

direction "A" shown in fig. 4 instead of the conventional direction "B", thus taking advantage of the greater friction effect in that direction. This, however, as is to be expected, increases the wear and tear on the rivets.

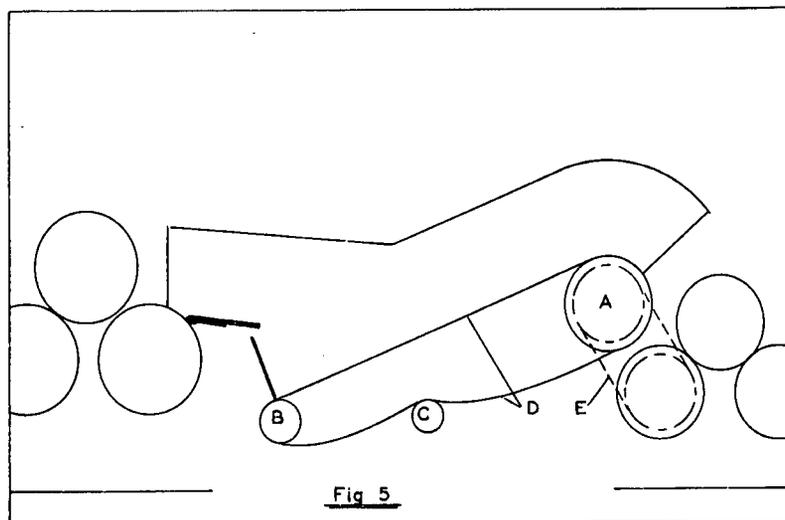
#### KEY TO FIGURE 5:

- A Drive shaft and sprockets.
- B Tail shaft and idlers.
- C Return idler.

- D Chain slat assembly.
- E Drive chain.

Increased throughputs brought about improvements in the design of the apron carrier as illustrated in fig. 5. The nose shaft was eliminated and the diameter of the drive sprockets materially increased. The chain slat assembly when wrapped around these large sprockets virtually became a feeder roller and because of the high pressure on the slats, it was found necessary to reduce the unsupported lengths of the slats between the sprockets by mounting broad rimmed support discs on the shaft between the sprockets. The elimination of the reverse flexing of the chain slat assembly considerably reduced the tendency of rivets to become slack. The increased number of sprocket teeth actually driving the chain further reduced the rate of chain wear.

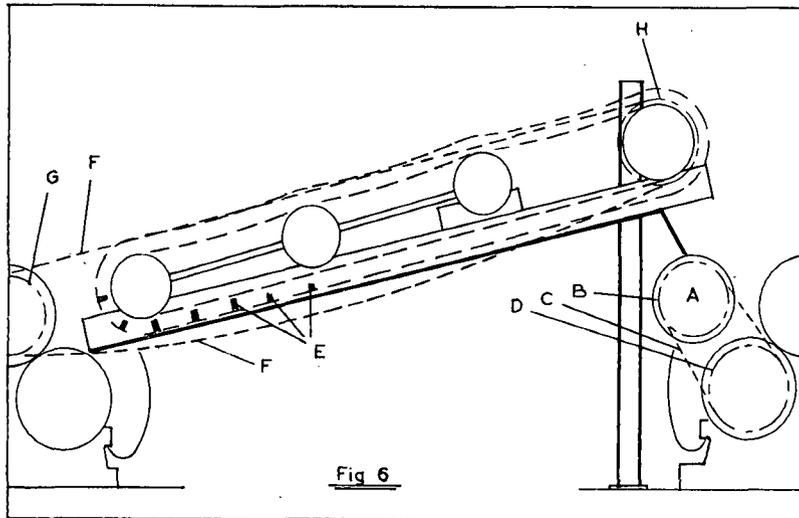
KEY TO FIGURE 6:

- |  |   |

| A Underslung feeder roller. | F Intercarrier drive chain. |
| B.C.D. Underslung feeder roller drive. | G Intercarrier drive sprocket. |
| E Slats and chain assembly. | H Intercarrier drive and driven sprocket. |

Because of high maintenance costs experienced with the apron type conveyors, Darnall in 1954 re-introduced the Ramsay type carrier. Tongaat followed in 1957 with the type of carriers as used in the sugar industry in Mauritius. This type of carrier, illustrated in fig. 6, makes no contribution to the feeding of the mill and is therefore used in conjunction with the now

very popular underslung feeder roller. Note that this carrier was driven by the previous mill by a chain drive. The bagasse is conveyed over fixed bottom plates by slats attached to two strands of chain. Chain speed was about 45 ft./min.

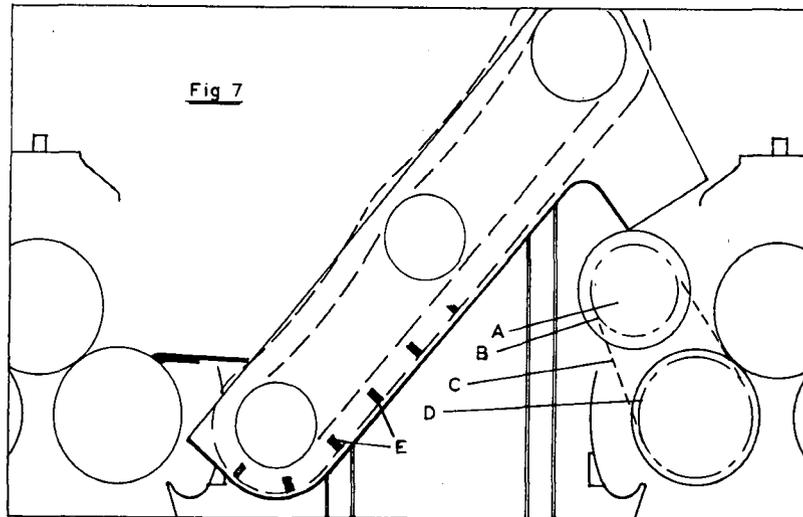
KEY TO FIGURE 7:

- |  |                            |

| A Underslung feeder roller. | E Slat and chain assembly. |
| B.C.D. Underslung feeder roller drive. | |

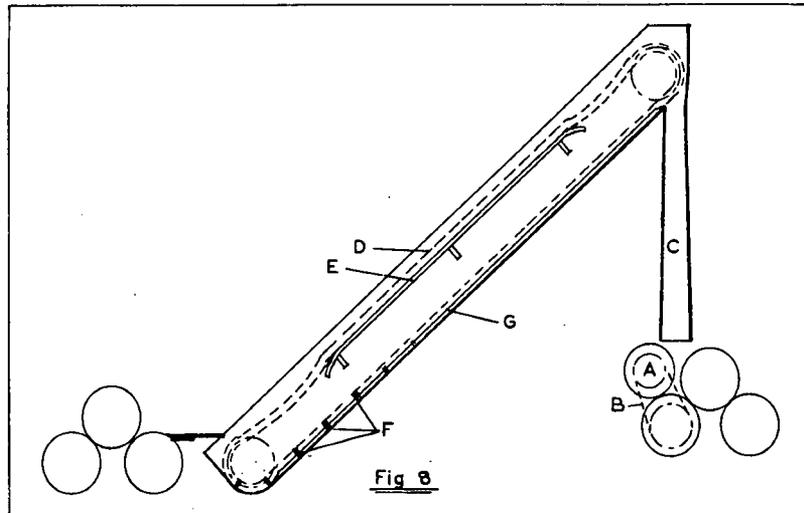
KEY TO FIGURE 8:

- |                             |                            |

| A Underslung feeder roller. | E Slat support runners. |
| B Drive. | F Slat and chain assembly. |
| C Donelly chute. | G Bottom plate. |
| D Chain runner. | |

effect on the design of the intercarrier was to increase both the angle of the carrier and the shaft centres. This type is illustrated in fig. 8. In some cases the carriers are inclined at angles of as much as 55° to the horizontal which in the opinion of the author, is the maximum permissible angle of inclination of a drag conveyor feeding a Donelly chute. In order to prevent choking at the narrow mouth of the Donelly chute it was found necessary to increase the speed of the conveyor so as to feed the chute with smaller dollops and speeds as high as 200 ft./min. are used in some cases.

At the beginning of the 1964 season a carrier of the type shown in fig. 8 and 10 was installed on the 66 in. tandem at Tongaat using 0906 chain (tensile strength 40,000 lb.) fitted with stainless steel pins and bushes and AS2 attachment links. The total elongations in this chain after one season's operation was 4 in., the carrier shaft centres being 27 ft. 3 in. Also in 1964 a non-detachable Renold chain of 85,000 lb. breaking strain fitted with stainless steel pins and bushes, which had already completed three full seasons (1959, 1960, 1961) on the Shredder Elevator of the Maidstone tandem was installed on a similar carrier to the one shown in fig. 8, and completed the season without giving any trouble. This chain will again be used in the 1965 season. At the time this chain was considered to be expensive, but its reliability and long life have proved its purchase to be an economic proposition.

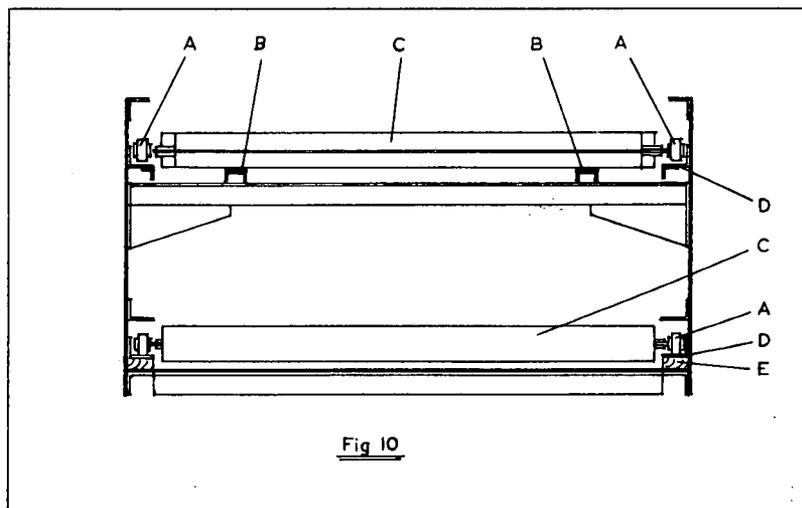
KEY TO FIGURE 10:

- |                        |                   |

| A Chain. | D Chain runner. |
| B Slat support runner. | E Wooden packers. |
| C Slat. | |

**Mr. Turner:** Referring to Figure 10 we find that most of our chain wear takes place between the roller and the outside of the bush. To obviate this we have put runner bars on the slat so that the rollers do not turn at all on the return flight.

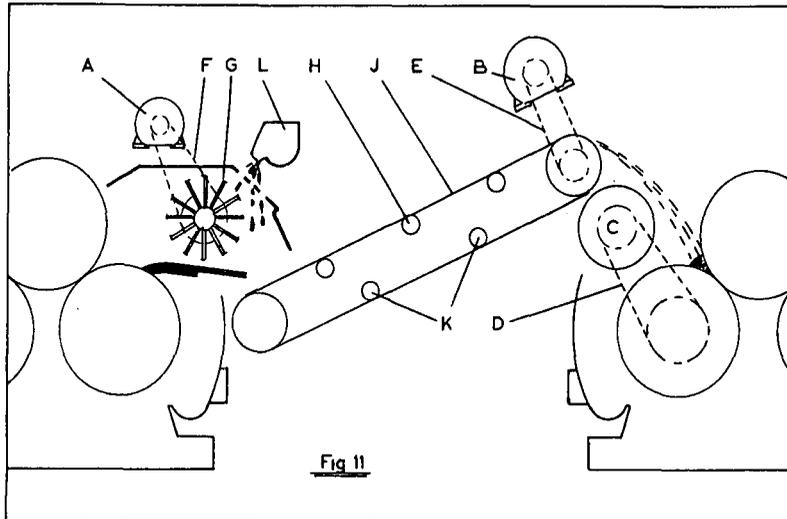
KEY TO FIGURE 11:

- |                                       |                      |

| A Macerator drive motor. | G Macerator. |
| B Carrier drive motor. | H Idlers. |
| C Underslung feeder roller. | J Rubber belt. |
| D Drive for underslung feeder roller. | K Return idlers. |
| E Intercarrier drive. | L Maceration trough. |
| F Macerator drive. | |

In 1962 Reviere type intermediate carriers illustrated in fig. 11, were installed between the 3rd and 4th mills and between the 4th and 5th mills on the 66 in. tandem at Tongaat. This type of intercarrier is a high speed rubber belt carrier running at about twenty times the peripheral speed of the rop roller of the mill. In the case of Tongaat this speed was 425 ft./min. The theory behind the high belt speed is that the bagasse which should theoretically be evenly spread in a thin layer about 1½ in. thick is fed into the mill in a steady stream at a velocity imparted to it by the belt. An underslung feeder roller, which is part of the equipment, is fitted as an emergency device only and is not intended to act as a feeder. The even distribution of the bagasse on the belt is effected by means of a multibladed rotor which rotates at about 300 r.p.m. in a maceration box. Part of the maceration is fed into the box to be intimately mixed with the bagasse and part cascades down the face of the box on to the

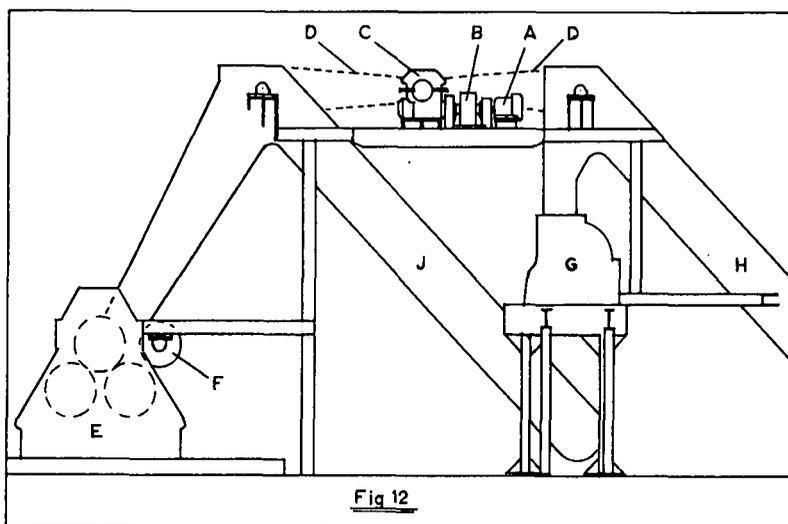
KEY TO FIGURE 12:

- |                            |                             |

| A Drive motor. | F Underslung feeder roller. |
| B Variable speed coupling. | G Shredder. |
| C Gearbox. | H Shredder elevator. |
| D Chain drives. | J Crusher carrier. |
| E Crusher. | |

By using a common variable speed electric drive for these two carriers and by interlocking the drive with the main carrier by means of tachogenerators, and sensing devices and by fitting a killer plate in the chute to the mill, a very simple and effective means of control is obtained. This arrangement is illustrated in fig. 12.

**Mr. Cargill:** In Figure 12 in the paper a simple way is shown of controlling the speed of two carriers simultaneously.

At Mount Edgcombe we regard the shredder as a good tramp iron finder and when a piece of tramp iron goes through the shredder we immediately stop elevator J and H simultaneously until we have found it. Then elevator J is slowly driven.

In this drawing both H and J would be driven, unless a clutch is placed between them.

**Mr. Dent:** There will not be a clutch between them but in the sprocket boss there will be a shear pin which can easily be removed.
