STEPS TAKEN TO REHABILITATE THE EFFLUENT TREATMENT PLANT AT PONGOLA SUGAR MILL

This paper deals with the remedial measures taken at the Pongola sugar mill to restore the performance of the Effluent Treatment Plant (ETP) with the objective of improving the quality of the final treated effluent. The Pongola ETP has been generously sized; however, over the years this capacity has been eroded due to high suspended solids ingress combined with elevated hydraulic loading. Incidents of water quality noncompliance with local regulations necessitated interventions to improve the quality of treated effluent. A programme of investigation to determine reasons for drop-off in performance followed by phased action plans to rehabilitate the Pongola ETP are detailed in the paper.

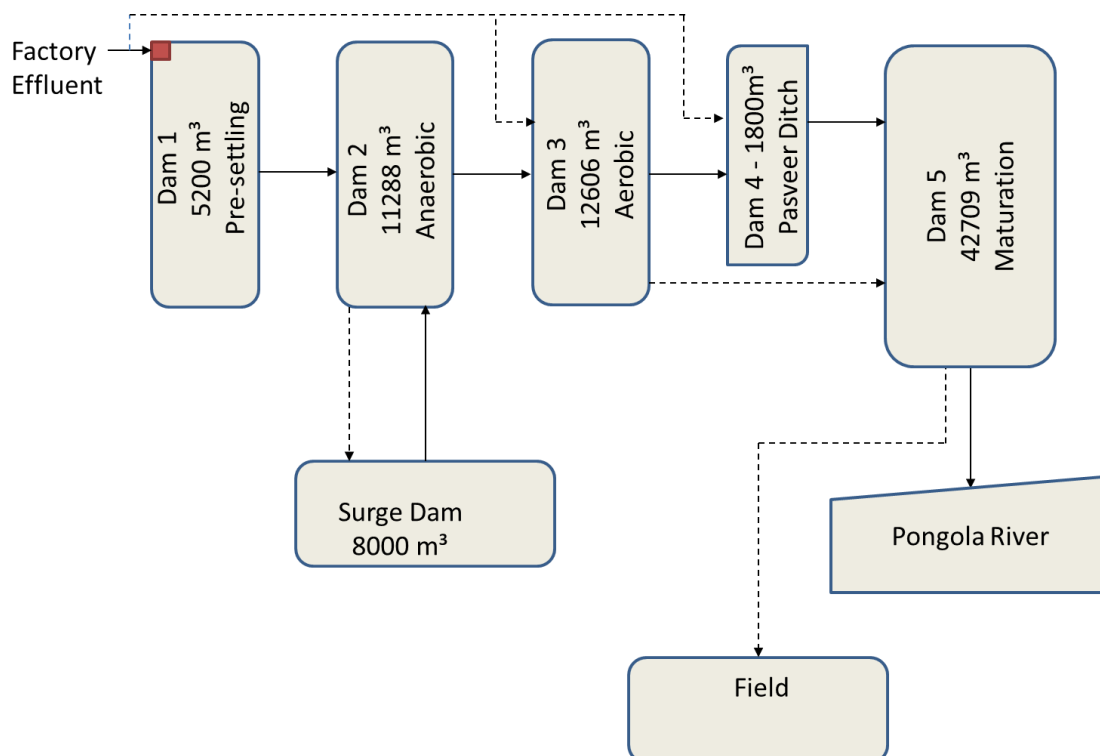
The Pongola sugar mill ETP comprises a combination of anaerobic digestion followed by aerobic digestion and a final polishing dam operating in sequence. The layout of the Pongola mill ETP, which is close to the Pongola River, is depicted in Figure 1. The treatment system was also designed with a surge dam to accommodate influent flow surges.

Figure 1: Layout of Pongola mill effluent treatment plant.

- Dam 1: A pre-settling dam with a capacity of 5,200 m³, it is a simple open lagoon type dam using gravity sedimentation to remove suspended solids. This dam also serves as an anaerobic dam. The designed retention period is three days. Sedimentation is a necessary treatment step to decrease suspended solids which would otherwise increase turbidity if discharged into a natural waterway inhibiting light transmission with resultant death of photosynthetic organisms.

- Dam 2: An anaerobic pond with a capacity of 11 288 m³, it is an open lagoon type anaerobic dam. The designed retention period is 7.5 days.
- Dam 3: An aerobic pond with a capacity of 12 606 m³, it is equipped with three floating, slow speed surface aerators driven by 22 kW motors. The designed retention period is 8.4 days.

- Dam 4: A Pasveer ditch of 1 800 m³, it is equipped with three 30 kW disk aerators. The designed retention period 1.2 days.
- Dam 5: A maturation dam of 42 709 m³ capacity for polishing effluent before discharge into the river. The designed retention period is 28 days.

- Surge dam: An anaerobic dam with a capacity 8 000 m³ to accommodate surges thereby preventing sudden high hydraulic loading into the treatment plant. The designed retention period is 5.3 days.

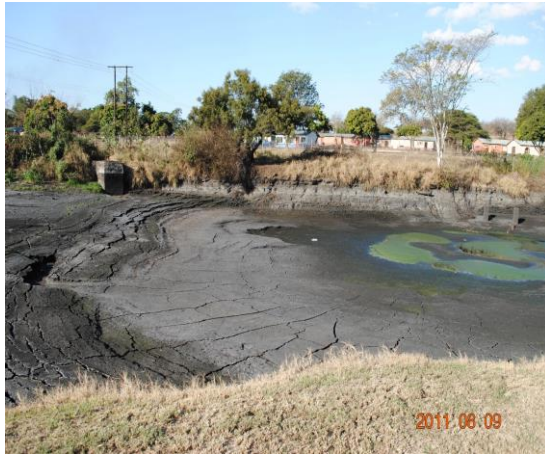
Figure 2. Dam 1 drying out for desludging.

The surveys conducted were useful in identifying problems and deciding the course of action to be taken. It was decided that the best approach would be a phased project programme to address rehabilitation of the dams. This solution was logical in that it was impractical to de-sludge whilst still maintaining operations. In addition, de-sludging is expensive and a phased operation allowed expenditure to be spread out. The de-silting of the dams required draining the liquid from the dams, drying out the solids under normal ambient conditions and removing the sediment utilising excavation machinery. The rehabilitation process commenced late in the 2009/10 milling season. One dam per year was de-silted to restore it to its original volumetric capacity. It is intended that the de-silting programme will now be an ongoing process.

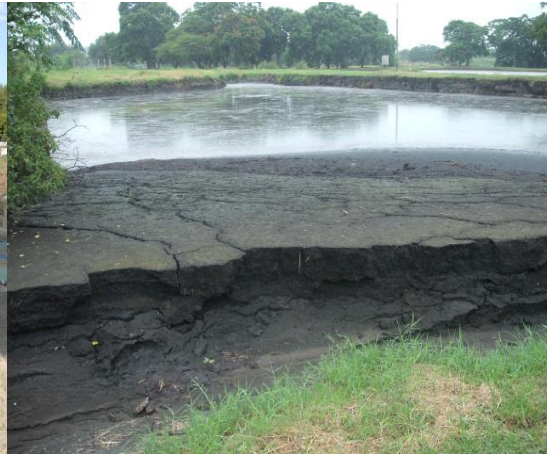
- The capacity of the ETP had significantly reduced due to the accumulation of solids. The chemical analysis of sediment shown in Table 2 indicated very high ash content and a low percentage of volatile matter in the sludge.

- The dam survey to establish the extent of silting has indicated a loss in treatment capacity of 30-50%, as shown in Table 3.
- Influent flow rates were recorded during normal and peak periods. These indicated an average flow of 1955 m³/day and a peak flow rate of 2880 m³/day.

Figure 3. Dam 1 silt accumulation.

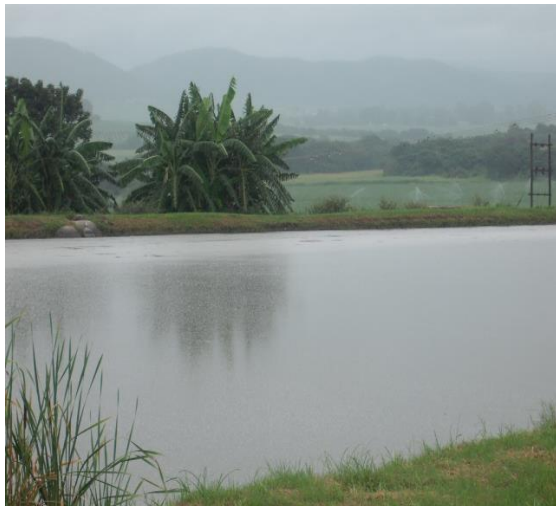
Figure 4. Anaerobic pond, Dam 2, indicating poor anaerobic activity.

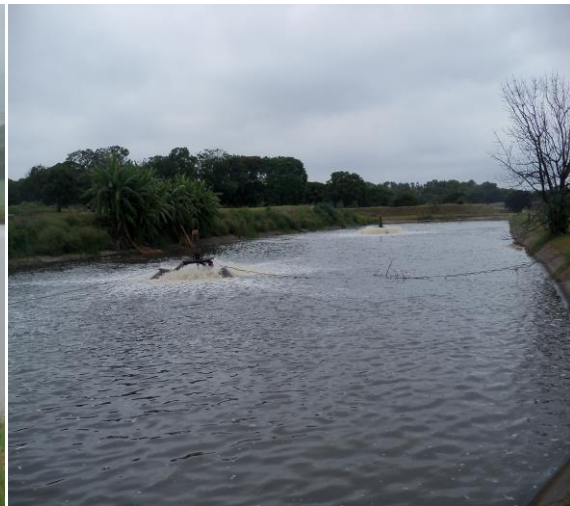
Figure 5. Dam 3 with two floating aerators instead of three aerators.

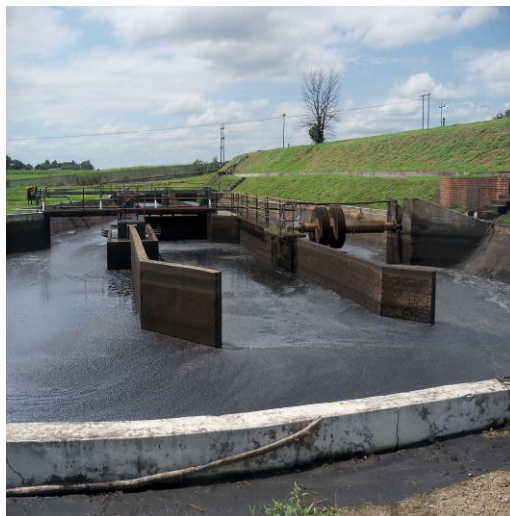
Figure 6. Ash-filled Pasveer ditch.

The utilisation of a flow model to monitor and optimise the ETP is regularly being applied to ETP operations. This model highlighted excessive power input to the Pasveer ditch, which would have had negative effects on retention of biological sludge. The excess power was due to the retroactive installation of two additional aerators for a ditch designed to run with a single aerator. The optimum power is calculated from knowledge of typical sludge concentrations and the potential COD abatement by the sludge. This is compared with the power required to supply oxygen for the required COD abatement. The calculations suggest that the sludge (at target concentration) is capable of removing 400 kg COD/d (if the ditch is free of silt) whereas the power input is sufficient for 522 kg/d. The limiting factor is the sludge concentration, which means that the power input is excessive. When inert silt occupies

50% of the ditch, the power input is approximately 2.5 times the requirement. Excessive agitation caused by the excessive power results in poor performance of the clarifiers with consequential reduction in sludge concentration, and preferential retention of inert silt. The installed power input per unit volume is approximately three times that of the Noodsberg Pasveer ditch.

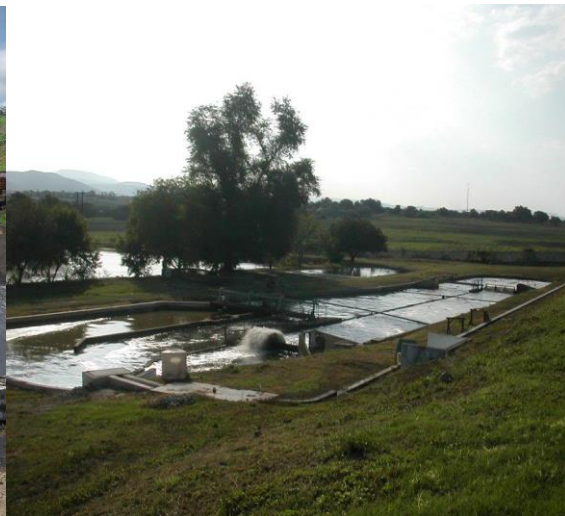
revealed carry-over of solids into all of the dams. The damaged disk aerators in Dam 4 as seen in Figure 7 had a detrimental effect on plant performance.

Figure 7. Dam 4 showing poor aeration with damaged aerator.

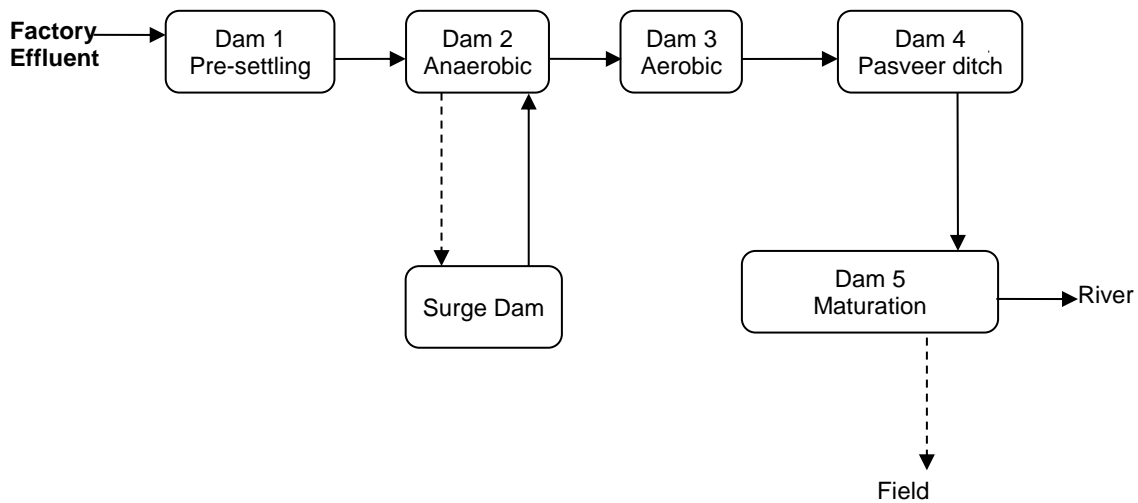
The inlet/outlet arrangements between dams 1, 2 and 3 caused short-circuiting of effluent through the dams which significantly reduced their respective treatment capacities and also resulted in carry-over of solids. The old flow arrangement is shown in Figure 8. It is planned to reposition these during de-silting work. The new arrangement is shown in Figure 9. Corrections have already been implemented on outflow from Dam 1 to Dam 2.

Figure 8. ETP old effluent flows from Dams 1 to 5.

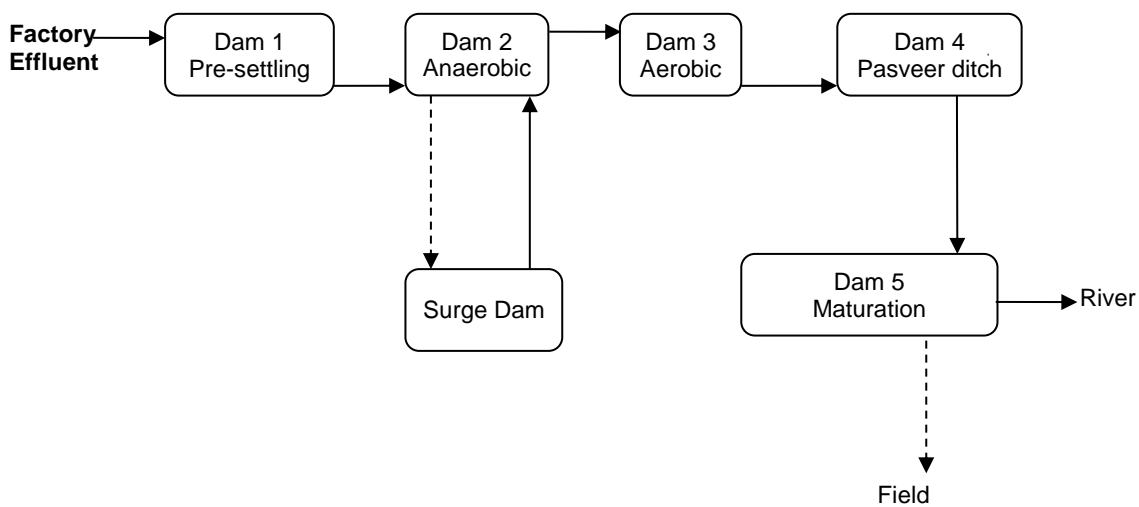
Figure 9. Current effluent flow arrangement.

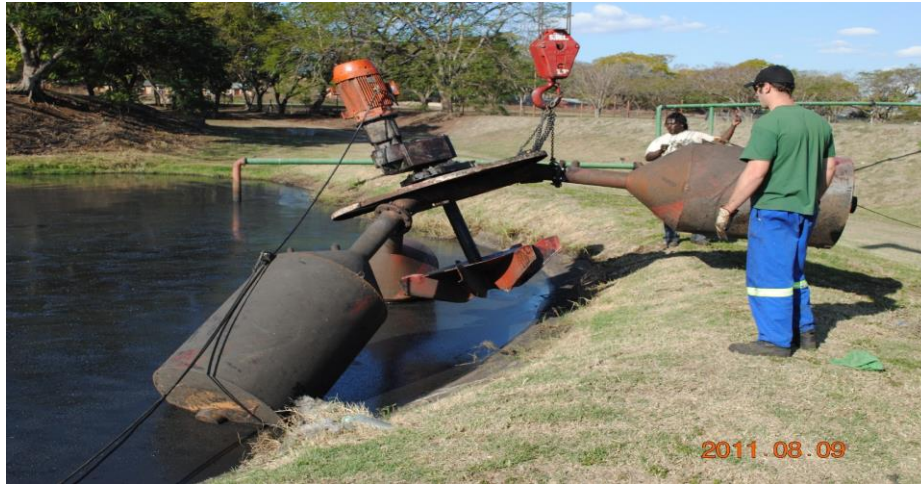
Figure 10. Floating aerator being removed for refurbishment.

Figures 10 and 11 show one of the floating aerators being removed from the aeration pond and the completely repaired aerator just prior to re-installation.

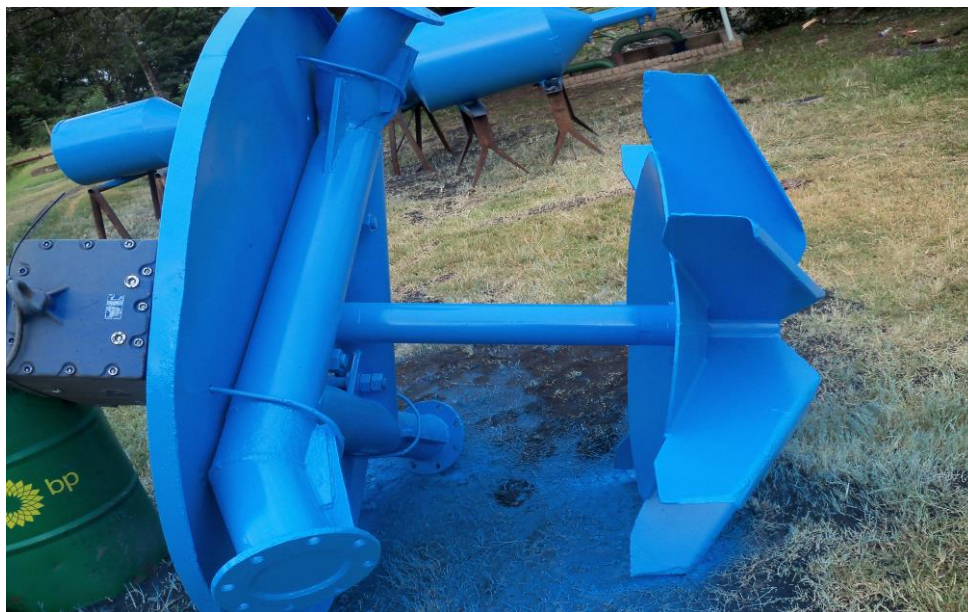
Figure 11. Refurbished aerator from the aeration pond.

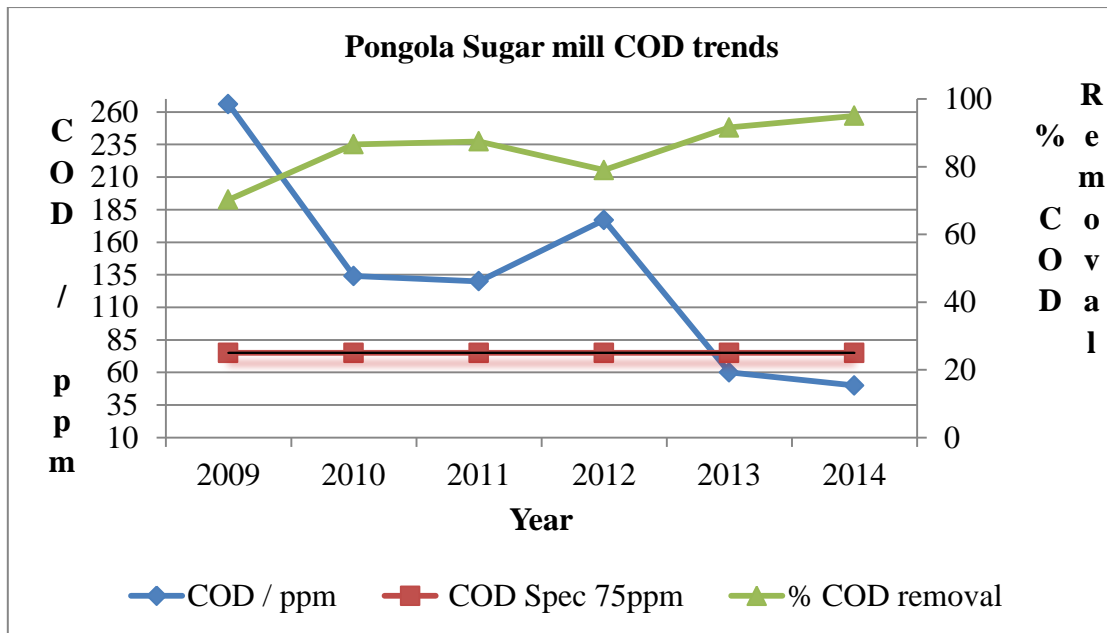
Pongola sugar mill's efforts to rehabilitate the ETP has resulted in a significant improvement in the performance of the plant. Figure 12 shows improving trends for percentage removal and COD trends over the past five years. The percentage COD removal improved to greater than 90%, resulting in the final effluent quality meeting specifications.

Figure 12: Effluent treatment plant performance trend over a five year period.

The outcome of the remedial work has revealed that the ETP is robust and works well, even at high hydraulic loading, provided the system does not become contaminated with solid ash. The recovery in performance of the plant was fairly quick once sludge removal was completed. This can be seen from Figure 12.

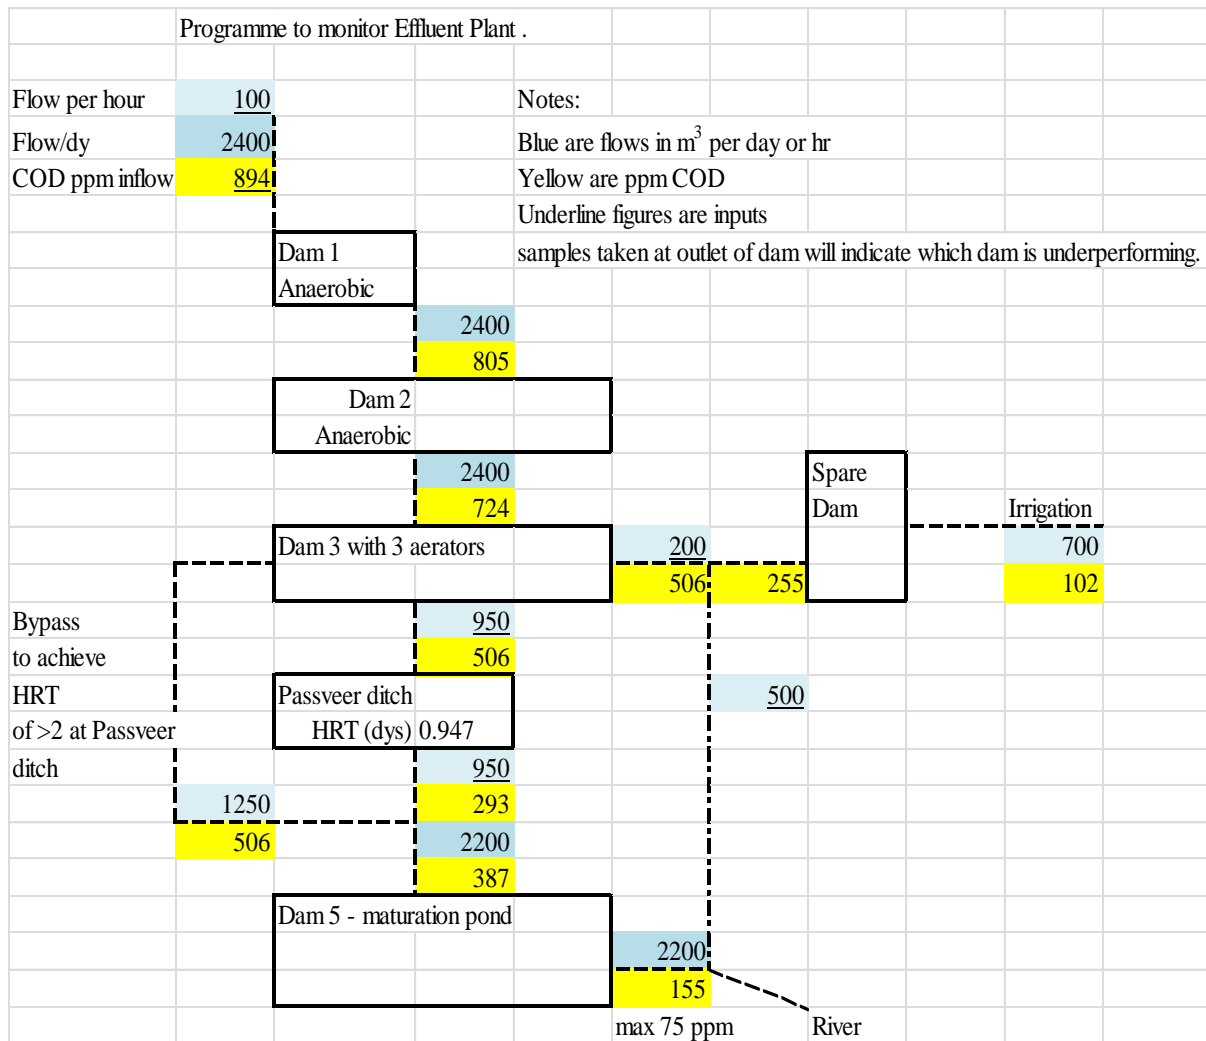
Appendix 2 Overview of Dr BS Purchase's flow model

Volumetric capacity of dams				
		Original (m ³)	% silted	Operating volume (m ³)
	Dam 1	5200	54	2392
	Dam 2	11288	34	7450
	Dam 3	12606	22	9833
	Pasveer ditch	1800	50	900
	Maturation	42709	30	29896
	Spare dam	8000	25	6000
Dam 1		m³/h	m³/d	
	Incoming effluent	100	2400	2392
	Incoming COD (ppm)	894		
	Total incoming (kg COD/d)	2146		
	Load (kgCOD/m3/d)	0.90		
	Abatement %	10		
	Total out (kg COD/d)	1931		
	Outlet effluent COD (ppm)	805		
	HRT (days)	1.0

- The regular and routine monitoring and control of the following key control parameters is considered to be vital: flow rates, nutrient content, COD loading, MLSS, SVI and suspended solids. A simple computer spreadsheet for the Pongola ETP was used to assist in achieving better control and improved monitoring of the ETP (Appendix 2).
