PROTECTION AGAINST FLOOD DAMAGE

By G. G. PLATFORD

South African Sugar Association Experiment Station, Private Bag X02, Mount Edgecombe 4300

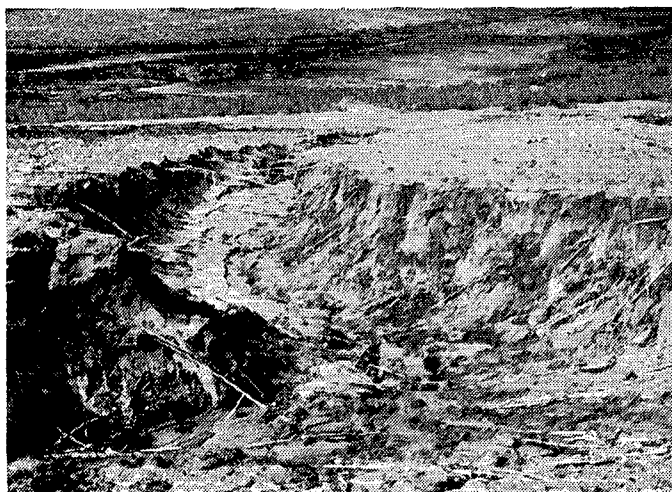
Infield damage: most of the damage occurred in fields where preparations for replanting cane using conventional tillage had been made or where cane had recently been planted. The worst affected areas were moderately steep slopes with shallow, fine-grained sands. Areas with Longlands, Cartref, Mispah, Westleigh, and Kroonstad soil forms were particularly vulnerable. Large landslips often occurred

where saturated topsoil overlay E-horizons or impermeable rock layers. These landslides were often triggered by erosion at the base of the slip. Infield roads, bridges, and crossings were frequently washed away. Massive gullies formed in some fallow fields (Figure 4).

FIGURE 4 Extreme soil erosion from a recently planted sugarcane field.

Storms of the duration and intensity of those in 1987 inevitably cause some damage. Where minimum tillage and strip planting were practised at re-establishment, minimal soil loss occurred. Even in steep areas on the south coast where these management practices had been applied, few gullies or rills were evident.

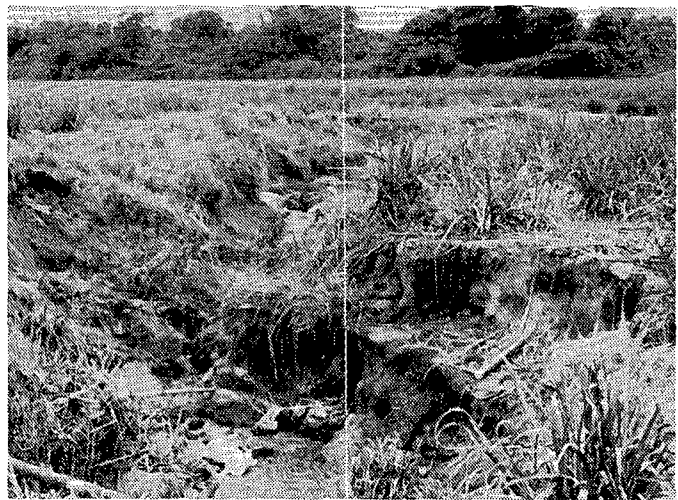
Waterway and streamline damage: because of the very large amounts of runoff, inadequately protected drainage lines suffered most, especially where the crop had provided little cover and in fields which were ready for replanting. Stream-bank erosion and undercutting of the banks, followed by further collapsing of the scoured portions commonly took place, but was mostly localised and influenced by the state of the catchment (Figure 5).

FIGURE 5 Streambank erosion showing banks collapsing due to undercutting action of the stream.

Sugarcane should be removed from the banks to a distance of at least 4 m. Any collapsed banks along drains or minor streams should be shaped with a blade or other suitable equipment to have a 1:1 slope. Work in vulnerable areas must only be undertaken during the winter months. Cane must not be planted within 3 m of the top shoulder of the shaped or stable channel side. If the channel base is V-shaped it should be flattened if possible. Various species of grasses, sedges and trees are suitable for planting along the sides and tops of the channels (Table 2).

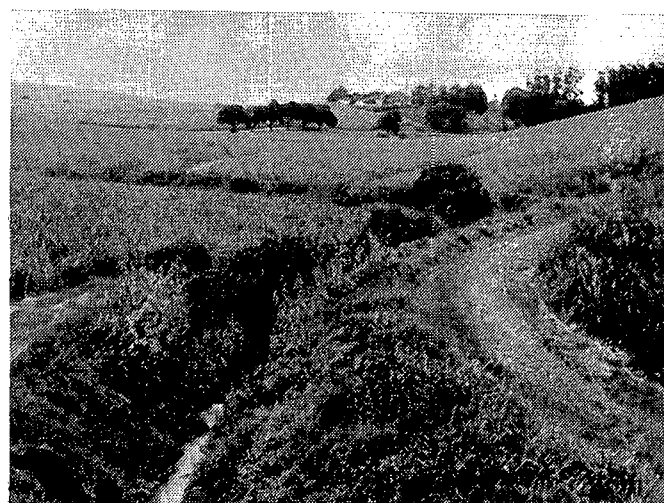
FIGURE 8 A well-protected stream in the Nonoti catchment.

Protection of drainage lines: depressions in the fields which are used as waterways and the minor drainage lines which contain a perennial flow of water must be protected by vegetative cover (Figures 8 & 9).

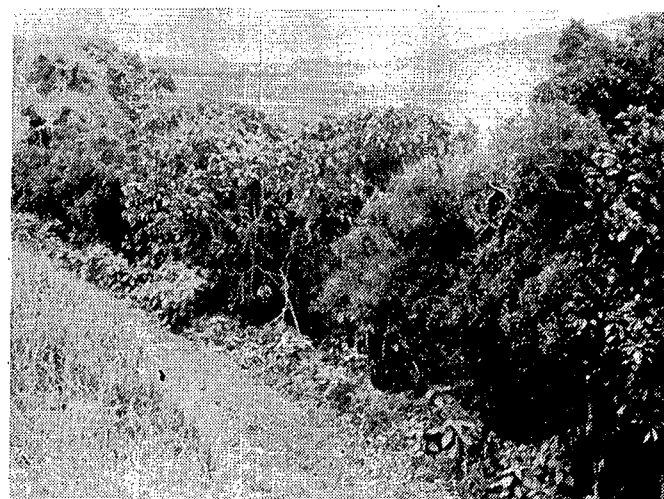
FIGURE 9 Indigenous trees used for protection along a stream.

The first stage in most protective systems, if the ground is not eroded, is the planting of a grass species to give a quick cover. Couch (*Cynodon dactylon*), Coastal buffalo grass (*Stenotaphrum secundatum*), or Kikuyu (*Pennisetum clandestinum*) are the preferred grass species. Thereafter 'pioneer' plants such as Mitseeri (*Bridelia micrentha*), Kosi (raffia) palm (*Raphia australis*), Umdoni (*Syzygium cordatum*) or Wild frangipani (*Voacango thangarsii*) should be established. There are mostly soft-wooded trees and shrubs which produce berries and seeds which attract birds. The birds feed on the fruit and import the seeds of many other varieties, which germinate and stabilise the habitat. Where gullies or damage have occurred in a drainage line, a decision must be made whether to stabilize and shape the newly formed gully or to initiate a complete reclamation programme.
