# FIRST IMPRESSIONS OF ADI CHAIN INSTALLED IN THE AMATIKULU DIFFUSER

Amatikulu Sugar Mill has installed Austempered Ductile Iron (ADI) block links and side plates on two diffuser chain strands. These links were cast in South Africa at a substantially lower cost than forged chain links. Some development emerged concerning the pattern, casting procedures and quality assurance required to ensure that high quality links were produced. Extensive tests were performed on the new links, including tensile and ultrasonic tests, and the cutting of cast links to inspect casting quality and procedure. Old links were also tensile-tested for comparisons.

The two chain strands have been in use for one season and have proven successful. Some links were disassembled for inspection after one season and the inspection results of these links and the rest of the chain are discussed.

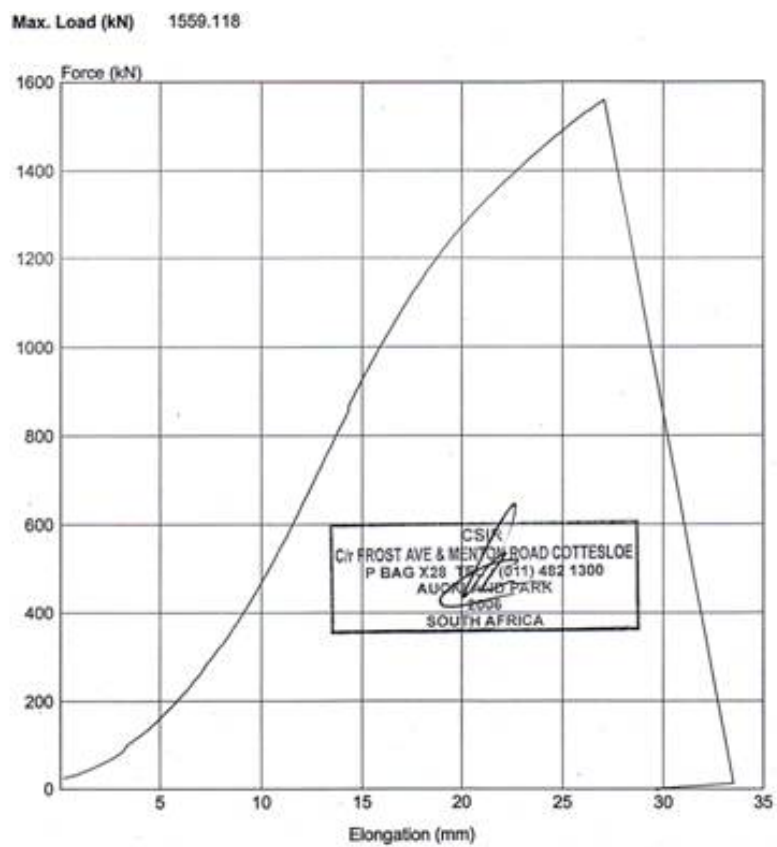
**Figure 11. Stress-strain graph for old links (B1-B2-L1-L2) in Figure 10.**

**Figure 10. Failed test sample B1-B2-L1-L2.**

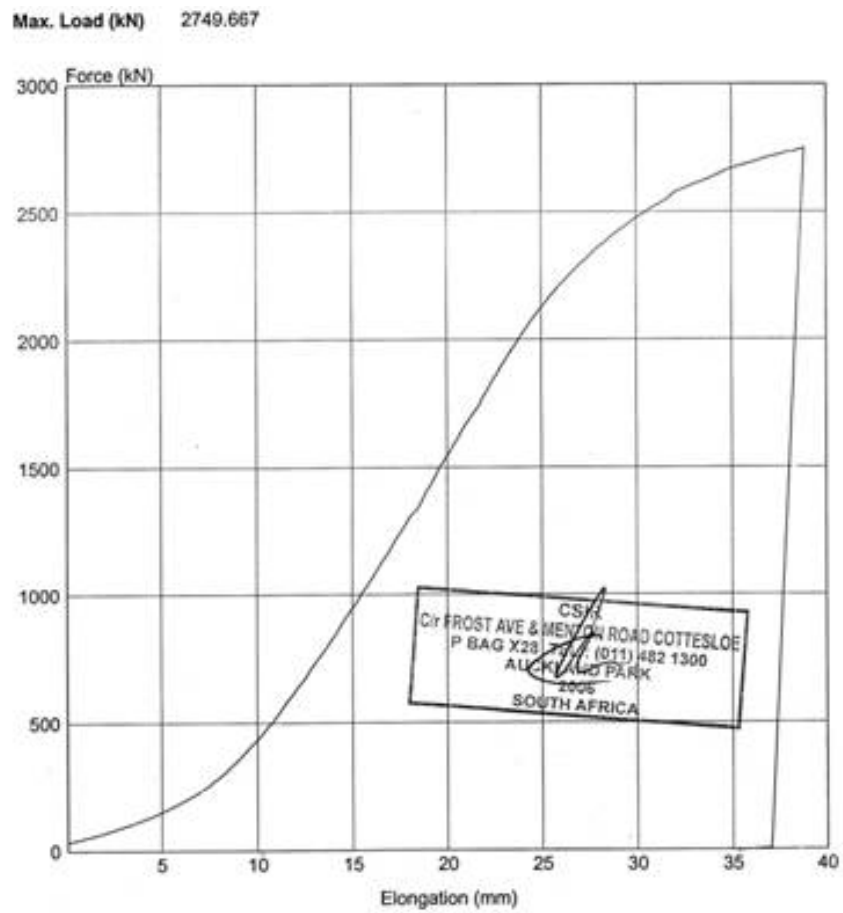
Figure 13. Stress-strain graph for link in Figure 12.

Figure 12. Failed new link 1 sample.

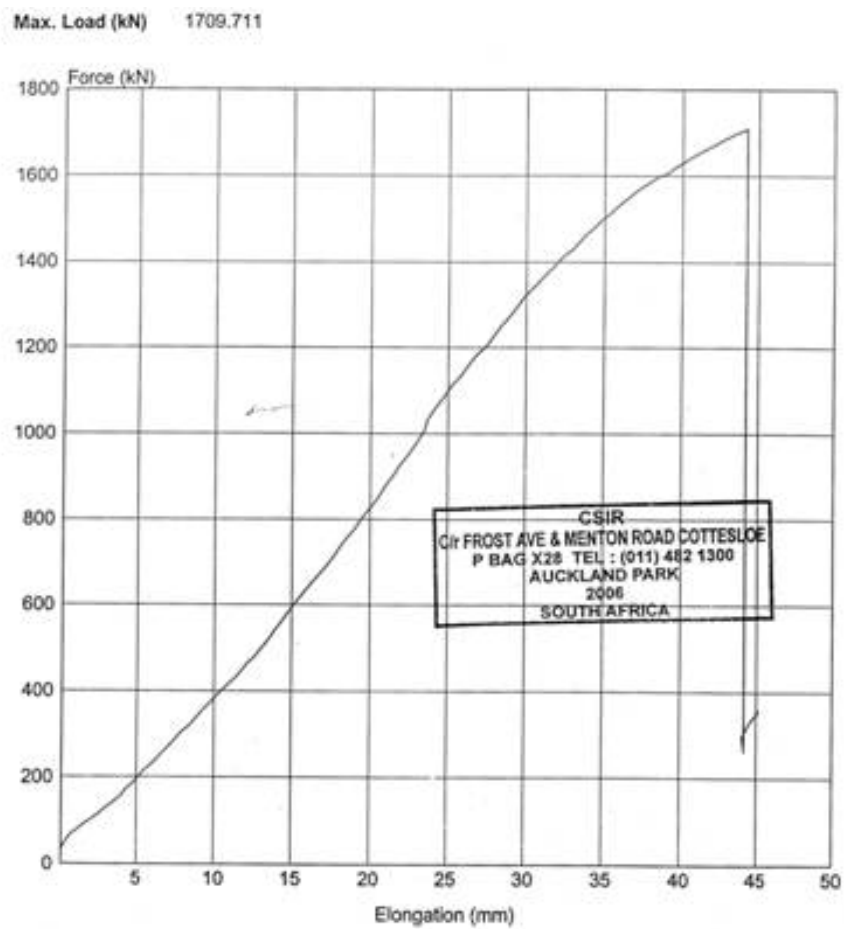
**Figure 15. The stress-strain graph of links B3-B4-L3-L4 in Figure 14.**

**Figure 14. Failed test sample B3-B4-L3-L4.**

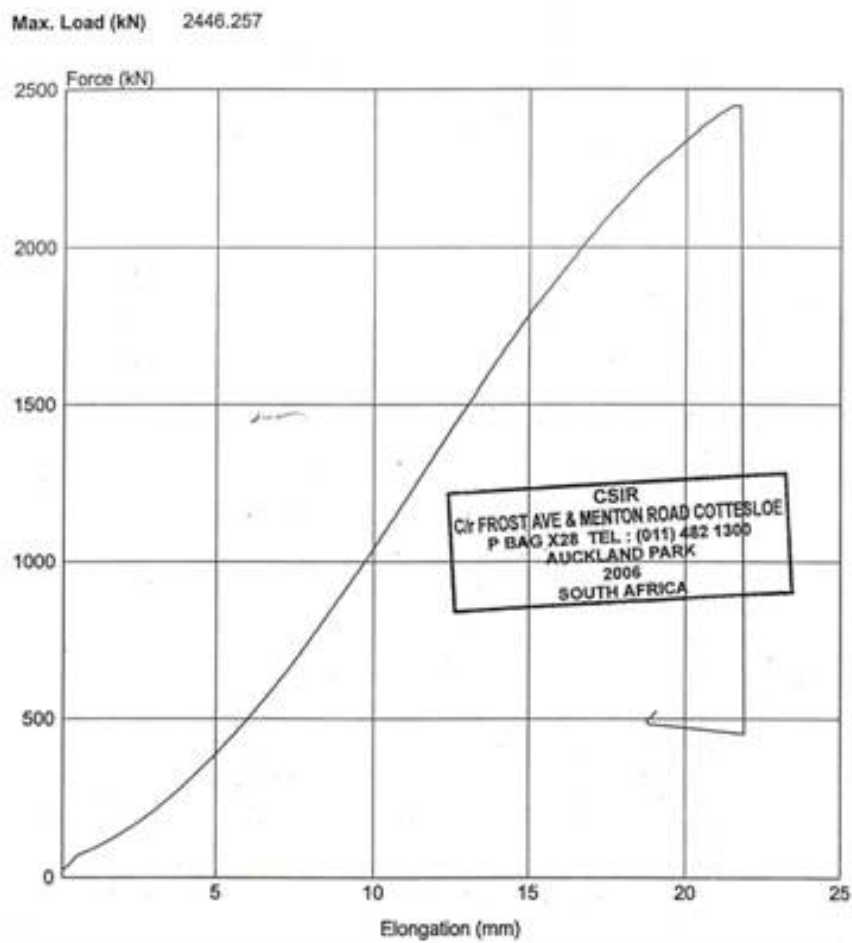
Figure 17. The stress-strain graph for links in Figure 16.

Figure 16. Failed defective new link 2 sample.
