# MECHANICAL REDESIGN OF ION EXCHANGE RESIN VESSEL BOTTOMS AT HULETT REFINERY

L SMITH

*Tongaat-Hulett Sugar Ltd*  
E-mail: [leon.smith@hulett.co.za](mailto:leon.smith@hulett.co.za)

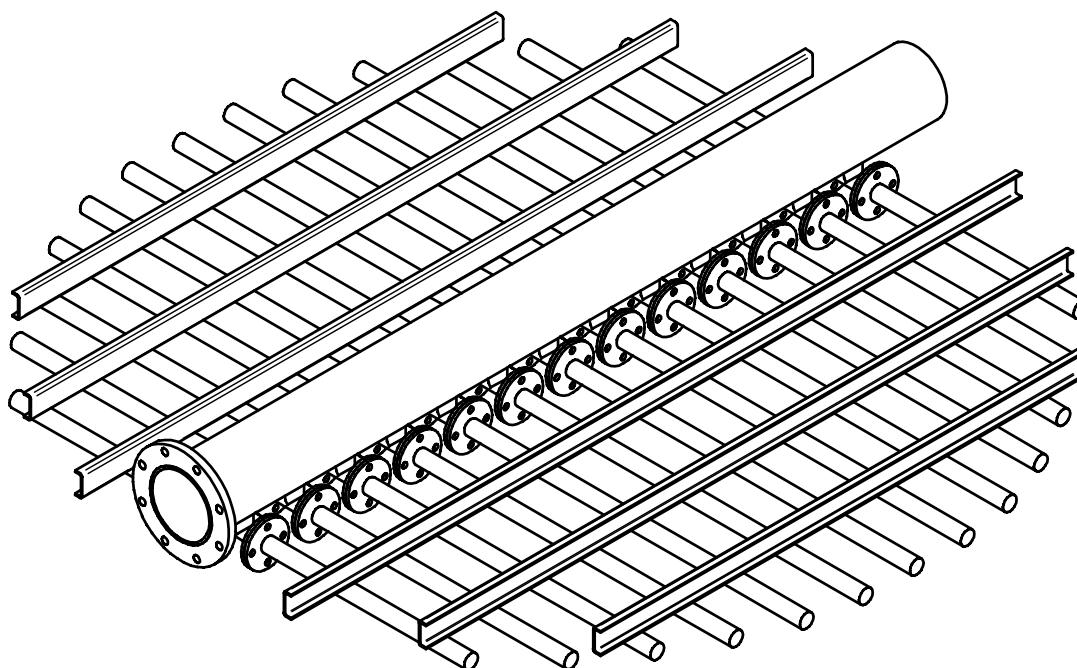
**Figure 2. Isometric view of bottom lateral distribution system.**

Repeated failures occurred on the LDSs fitted to the fabricated flat bottom vessels. These failures included bending of the distributor pipes and support channels, rupture of pipes, failure of the filter cloth and tearing off of the support lugs from the vessels cylindrical wall.
